# Architect's Advice Report

Client: <b>Zhao Yang Lin</b>	Telephone:
Address: <b>8 Rob Roy Street Glen Waverley – Inspection address : 467 Station Street Box Hill</b>	
Weather conditions on the day of Advice: <b>Fine</b>	Date of Advice: <b>28/9/11</b>

**Request to inspect an existing residence located at the above address in relation to the City of Whitehorse's heritage assessment of the property for potential future inclusion in the Heritage Overlay :**

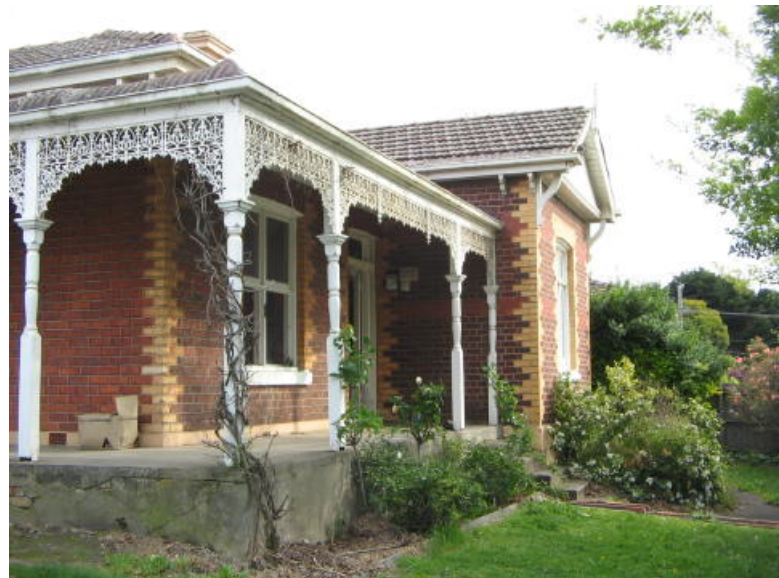
The shape of the front verandah is original however the concrete floor finish and concrete rendered face to the verandah do not appear to be original. Brickwork was noted under the render around the front of the verandah however the bricks do not match the bricks in the walls of the house.

Front of house showing rendered face to verandah & concrete floor. Also showing tiled roof.

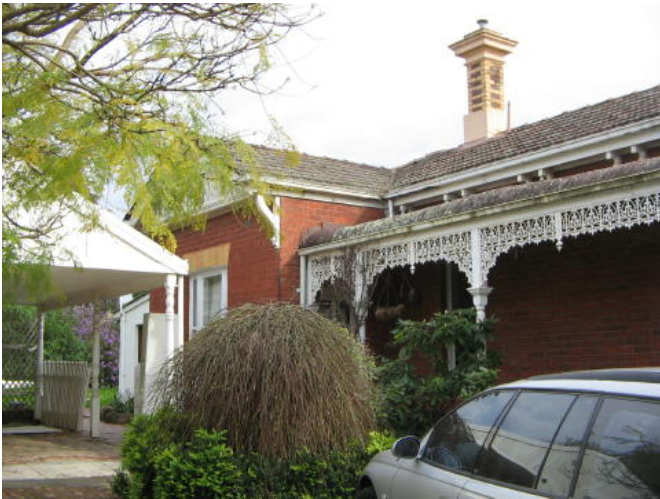
The condition of the house externally is in fair condition however house generally is in need of maintenance and repair. Some work is required to the tiled roof and flashings. It is not known when the slate roof was replaced with tiles.

South side of house showing tiled roof.

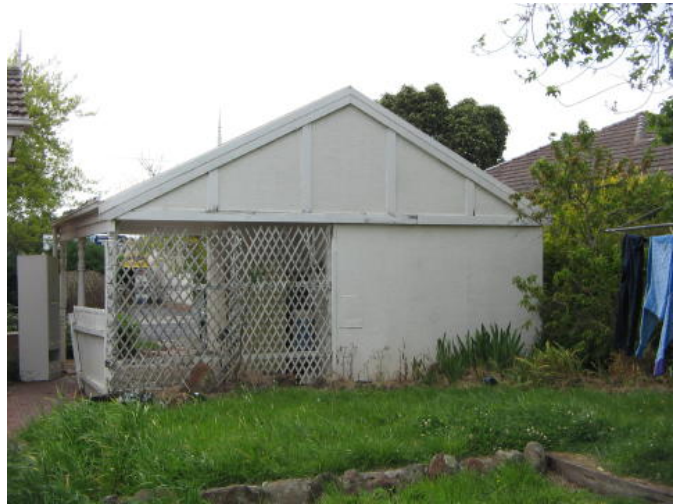
There is a timber framed garage located between the house and the south boundary. This structure is not considered an original structure and would have been constructed well after the construction of the main house. The actual date of construction is unknown.

Timber framed garage on south side of house.

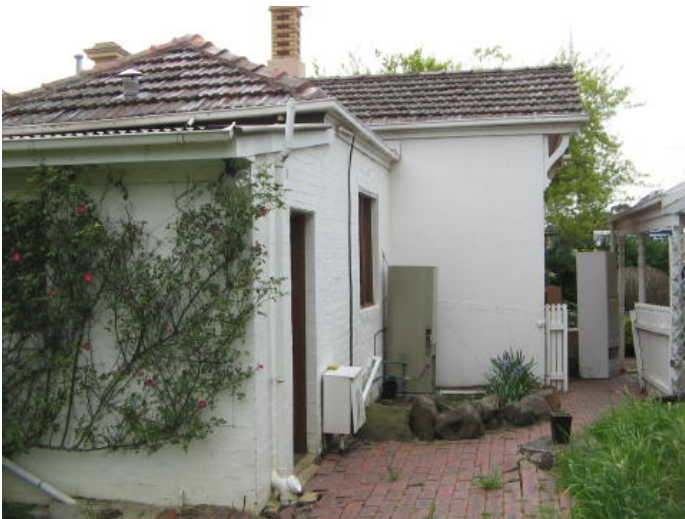
The gutter to the tiled pitched section of roof at the rear south west corner is at lower level to the front section of the house further indicating that the rear of the house is not original. The rear of the house does not have the original features incorporated in the main house at the front.

Rear of house south west corner showing gutter level & corrugated iron roof.

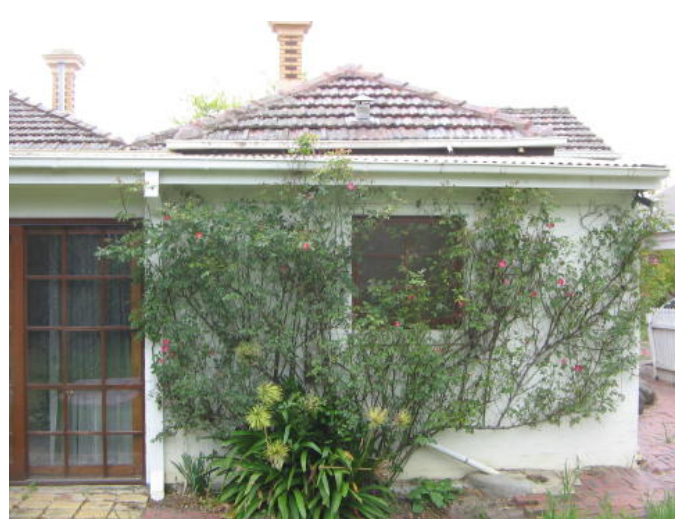
The roof framing and cladding at the rear is in two sections. Both are corrugated iron with a flat pitch. The structure across the back varies in the brickwork and actual wall construction. One section has large floor to ceiling timber framed windows and a glass sliding door. The main house has a timber floor whilst sections of the floor across the rear are concrete.

Rear of house showing full height windows.

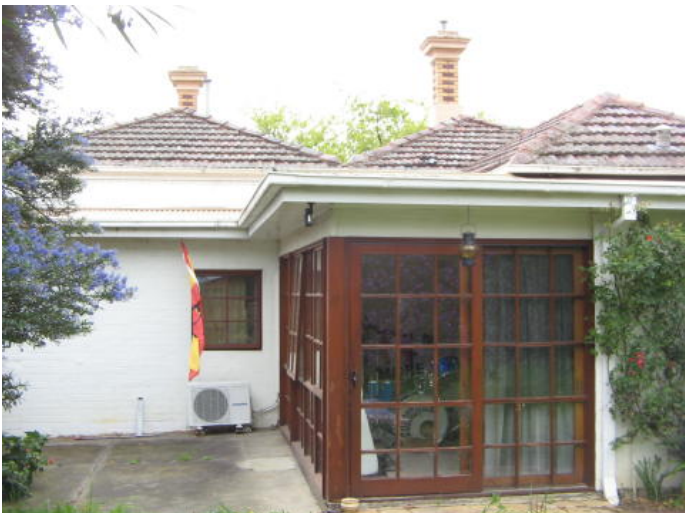
Rear of house Showing full height windows.

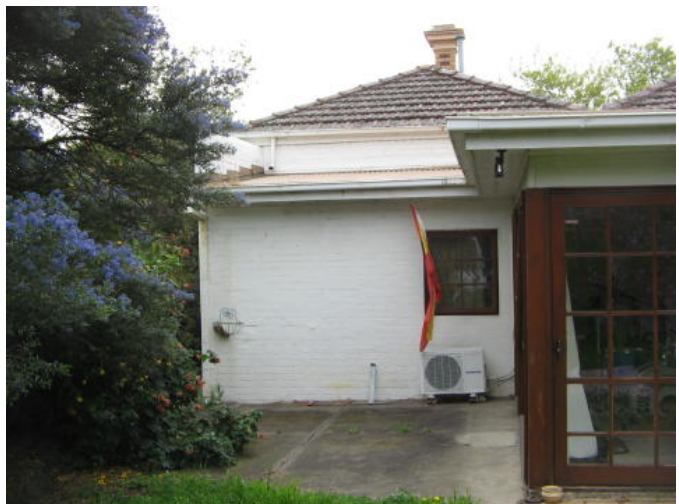
Rear of house north side

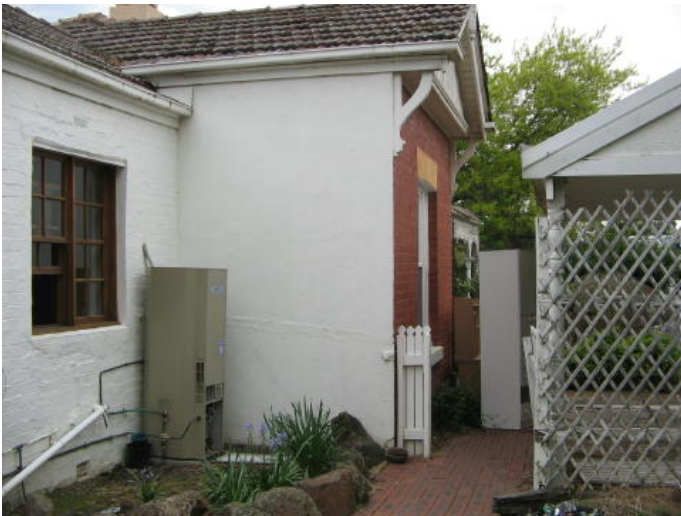
Rear of house and garage

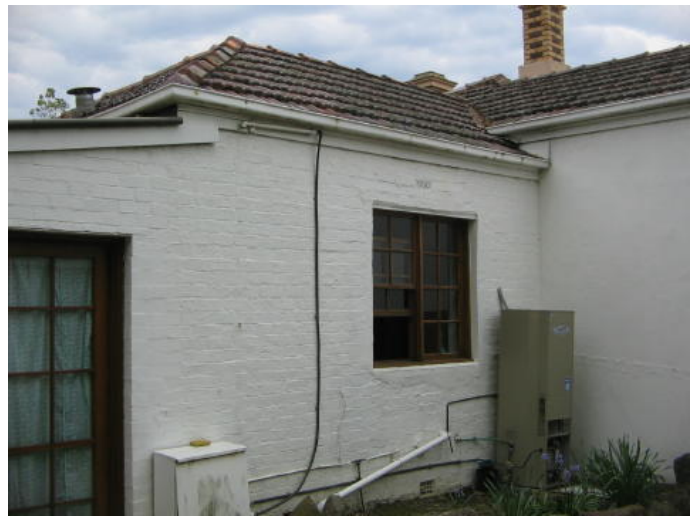
South west corner of house showing gutter heights.
