20 July 2012

Crossway Baptist Church
 Attention: Russell Oettinger
 2 Vision Drive
 BURWOOD EAST VIC 3151

**WHITEHORSE PLANNING SCHEME AMENDMENT C123: CROSSWAY BAPTIST CHURCH
 LANDFILL GAS RISK ASSESSMENT – FORMER LANDFILL, 51 SPRINGVALE RD, GLEN
 WAVERLEY**

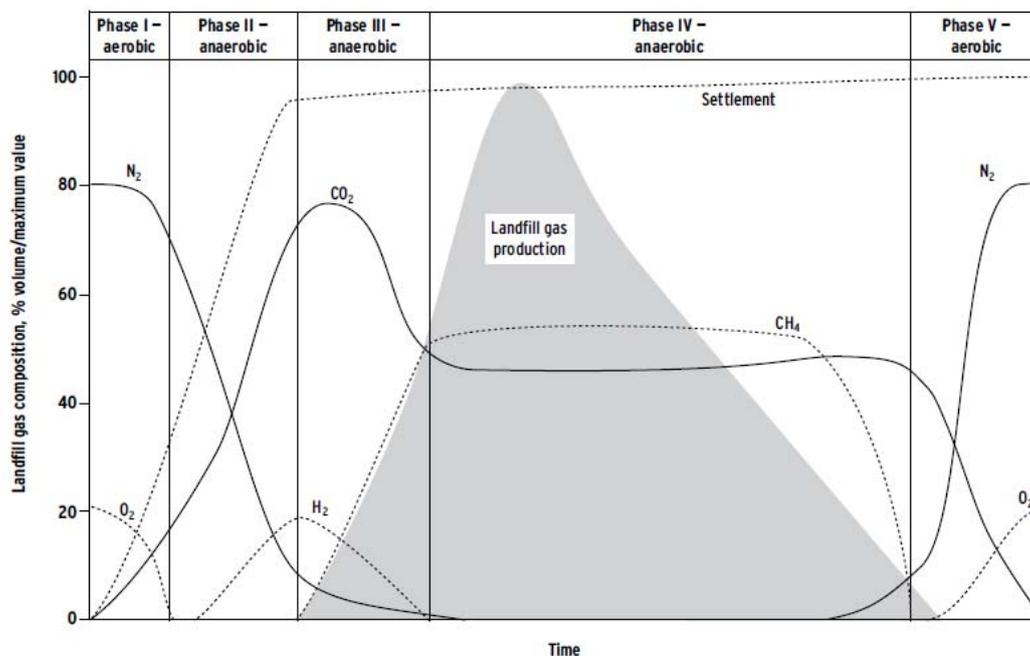
Figure 1: Idealised representation of landfill gas generation in landfills

- The landfill was likely only operational for less than 10 years, with closure occurring about 1972;
- The landfill has now reached at least 40 years since closure and LFG generation is now considered to be well into "*Phase V – Aerobic*" stage, (i.e. little if any LFG generation) as shown in Figure 1;

Figure 1 below shows idealised representation of LFG generation in landfills.
