TREE MANAGEMENT PLAN REVISED MARCH 2019

160 WHITEHORSE Rd BLACKBURN

MARCH 2019

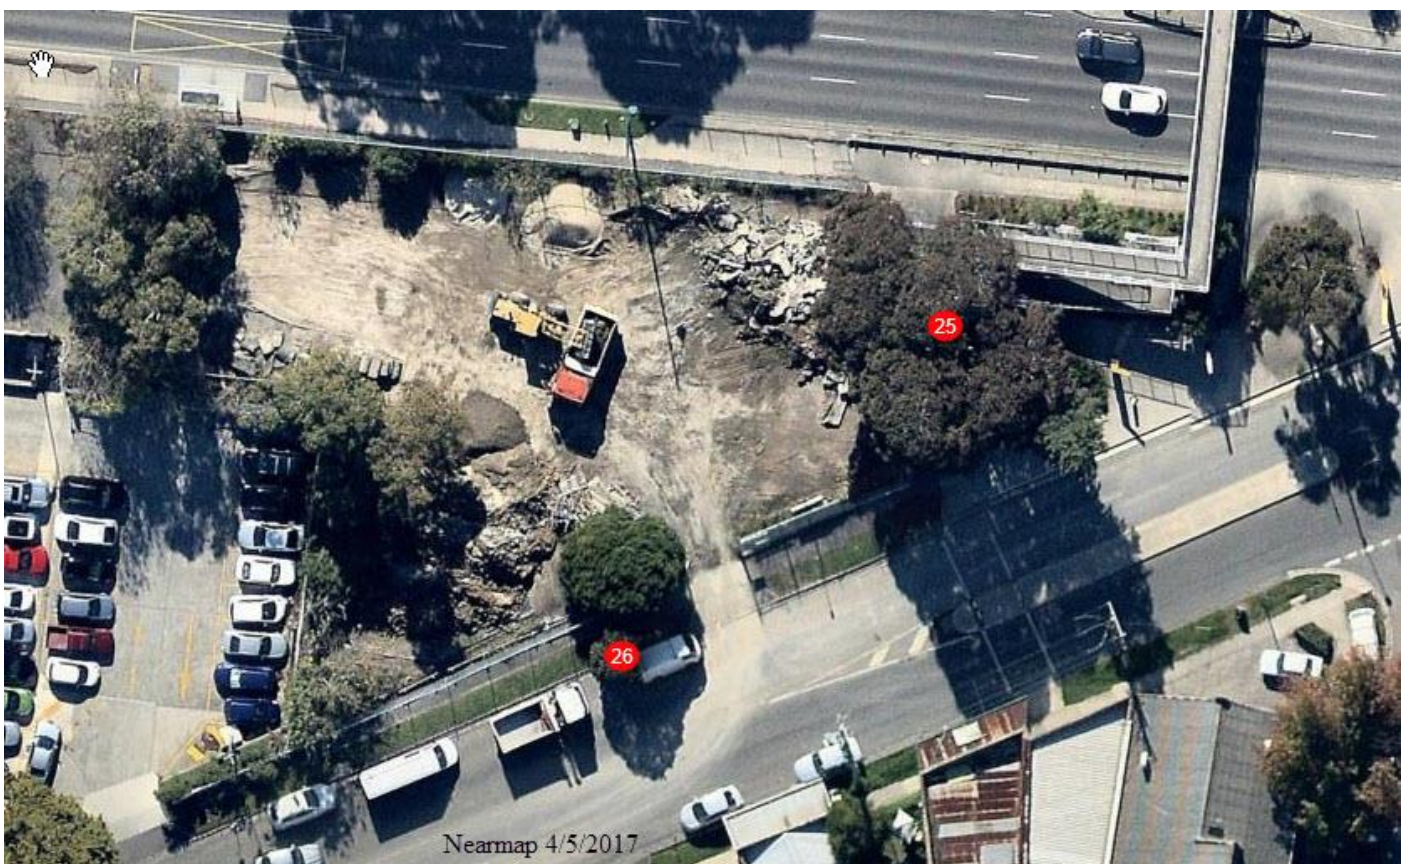
5.3.3.1. This is a large tree in fair condition, which adjoined an open area which has been vacant for many years and was recently used as a storage area in the State Government’s railway crossing removal project as seen in **Photograph 2** below.

5.3.3.2. As can be seen in the above photograph, the area surrounding the base of the tree has been subjected to considerable compaction from the weight of stored material plus the consistent traffic of loaders and trucks.

5.3.3.3. Compaction has the effect of limiting oxygen and water penetration into the soil, both of these components are vital to the welfare of any tree.

5.3.3.4. During the inspection in March 2017 the tree showed little signs of distress and the recent photographs don't show any major reduction in the tree's health.

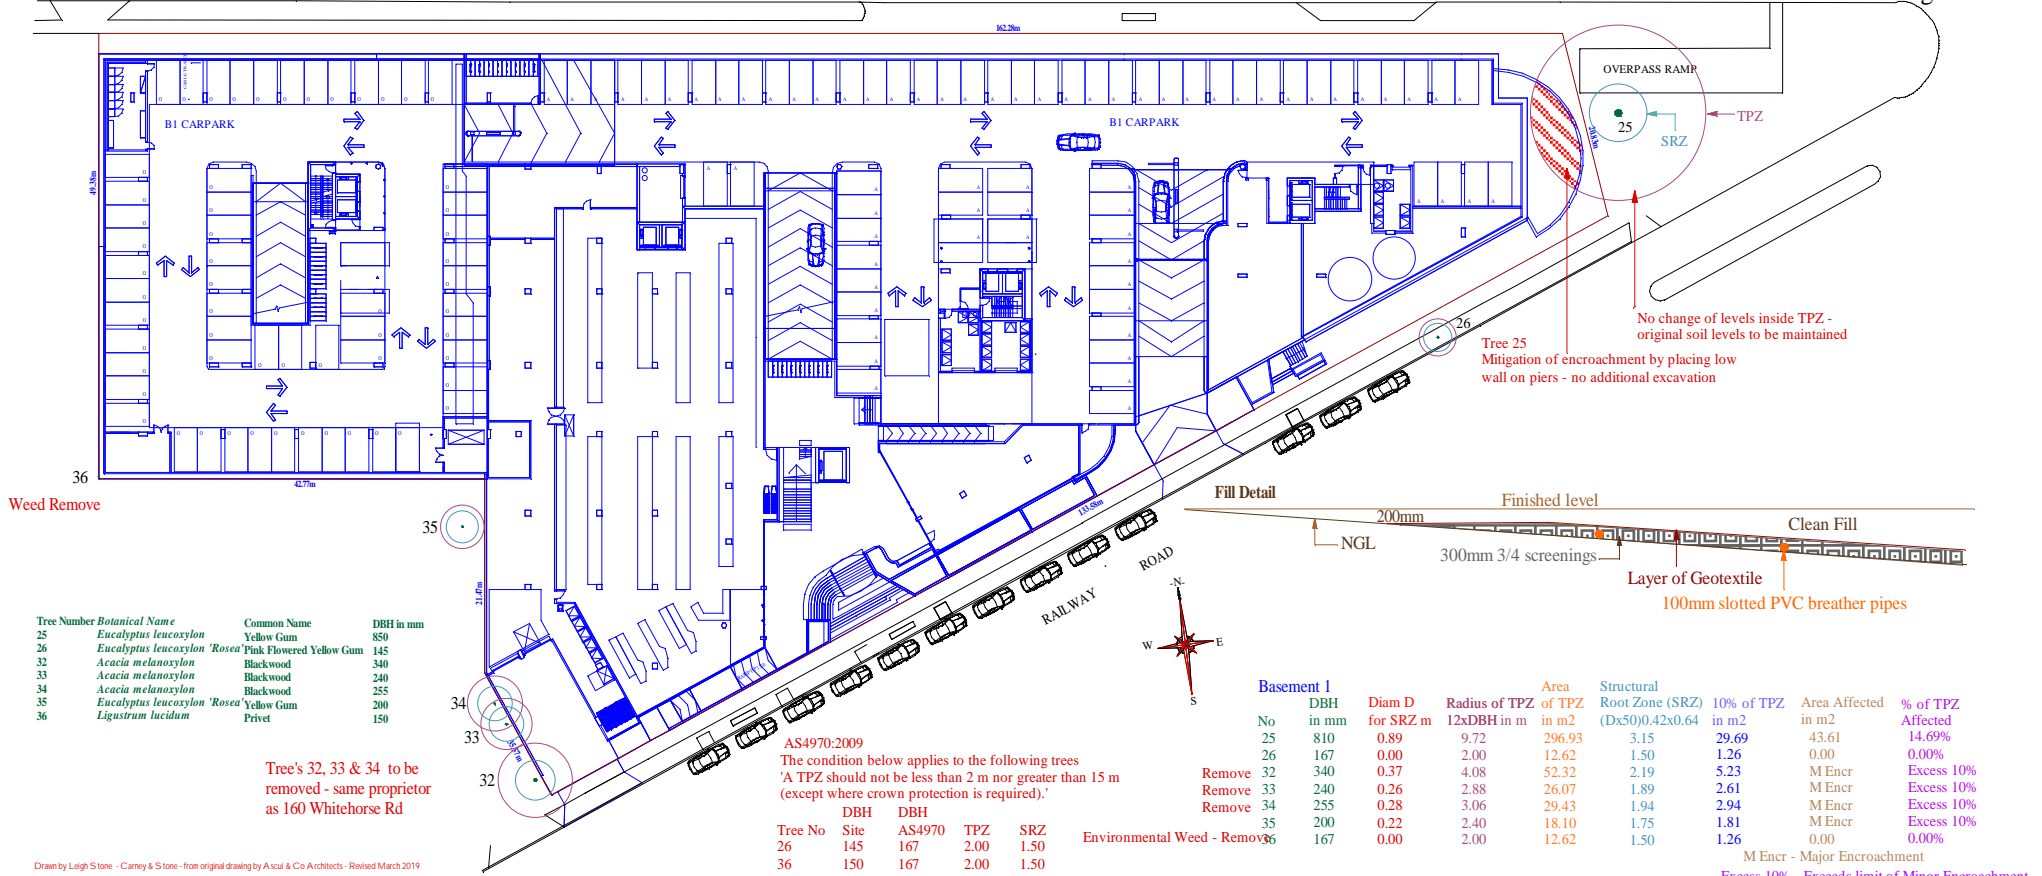
Drawing 1

5.3.3.6. As can be seen in **Drawing 1** the low wall adjoining the tree produces an encroachment of **14.69%** if a conventional footing is used. To reduce the impact of this wall and reduce the encroachment to well below the 10% *Minor Encroachment* as suggested in the Australian Standard AS4970:2009, the wall must be constructed on piers leaving the surrounding soil untouched.

Tree 25
Mitigation of encroachment by placing low wall on piers - no additional excavation
No change of levels inside TPZ - original soil levels to be maintained

Tree's 32, 33 & 34 to be removed - same proprietor as 160 Whitehorse Rd

5.3.3.6.1. All pier holes to be hand dug to 500mm, avoiding roots in excess of 30mm.

5.3.3.6.2. There is to be no excavation in the existing ground levels.

5.3.3.6.3. Any fill over the root zone of the tree in excess of 200mm, is to have a layer of screenings placed on top of the existing soil as set out in the '**Fill Detail**' on **Drawing 1**.

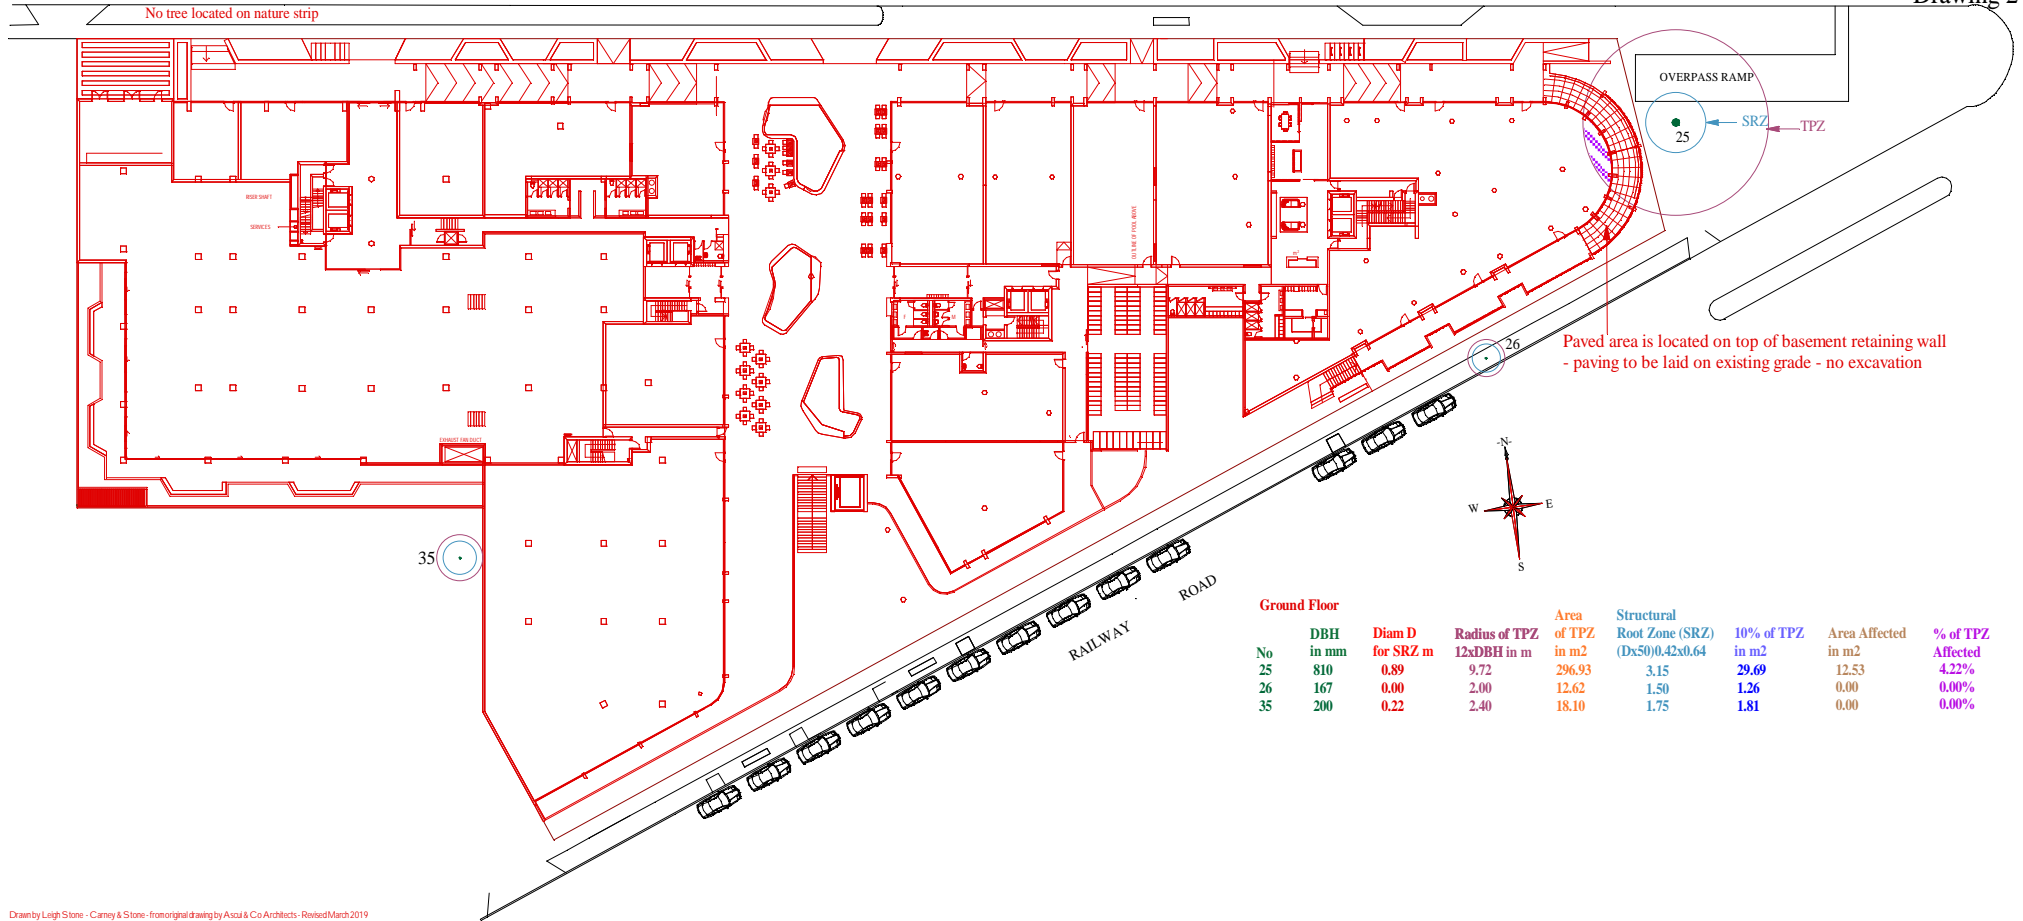
Drawing 2

5.3.3.7. **Drawing 2** to covers the intrusion of the construction of the ground floor. This encroachment is limited to **4.2%**.
