HERITAGE AND CONSERVATION STUDY

VOLUME THREE

CITY OF BOX HILL

**CITY OF BOX HILL
HERITAGE GUIDELINES**

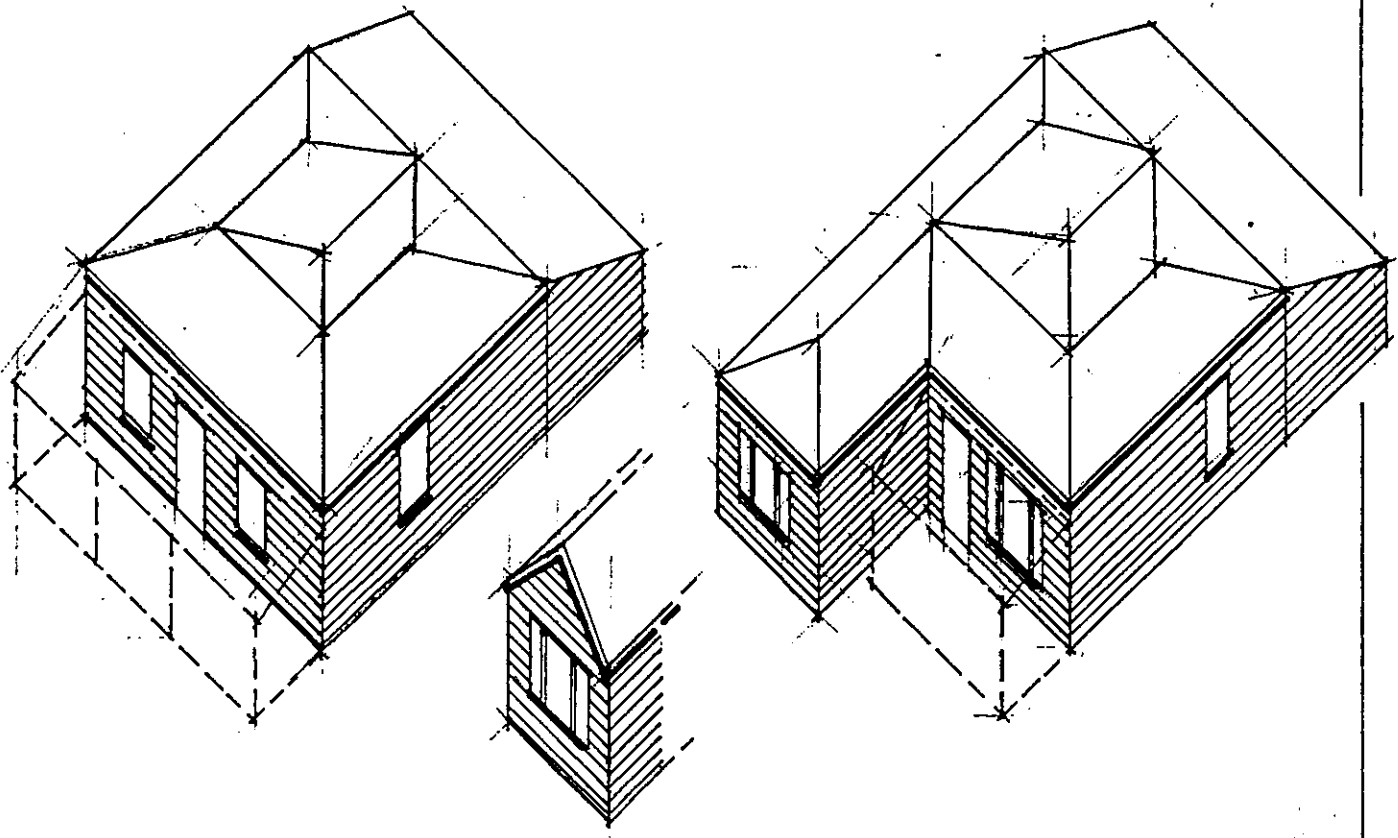
basic classical revival villa forms

These shapes encompass the majority of house types found in Box Hill and are most commonly associated with stereotypical and comparatively simple ornamentation.

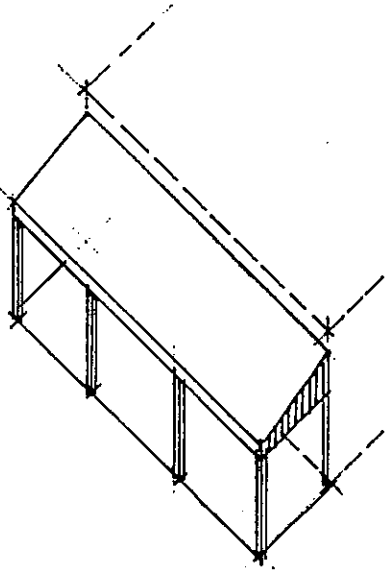
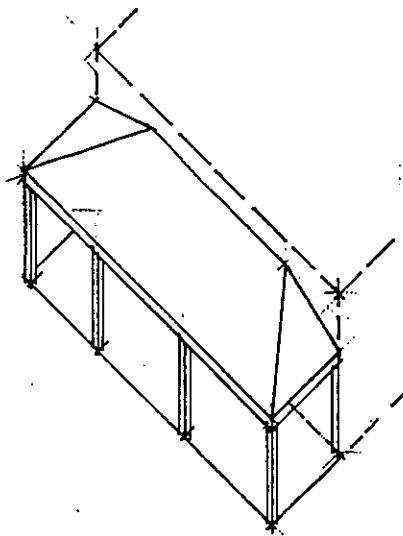
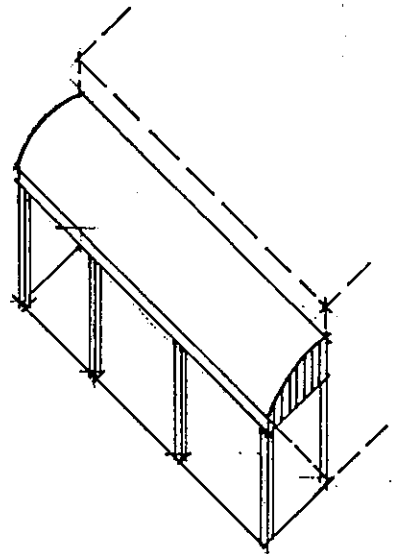
STRAIGHT

HIPPED

CONVEX

basic classical revival verandah forms

Verandah shapes and details representative of those found in Box Hill are mostly straight, with or without hips, and concave. They were most commonly applied to the front of buildings but also quite frequently extend around one or two sides.

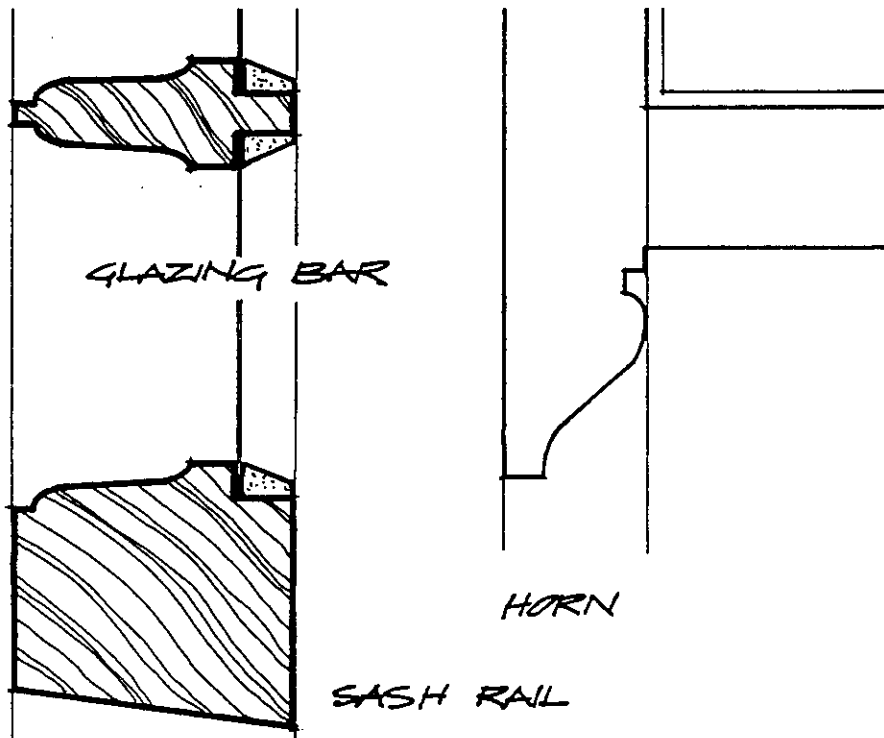
Windows were typically double hung with each sash having either one pane, or two formed by a central vertical glazing bar. Less commonly, each sash would have six small panes but these were generally relegated to the less important side and rear elevations. Similarly, most sashes had horns, only the very early examples being without them. Typical profiles and details are shown:

Where a view or additional light were sought, a large central double hung window was often flanked by narrow double hung windows. Sometimes the narrow windows were glazed with acid etched and coloured glass. Tall windows opening onto terraces or verandahs were also double hung and sufficiently lofty to allow an adult, by stooping slightly, to walk over a low sill onto the verandah.

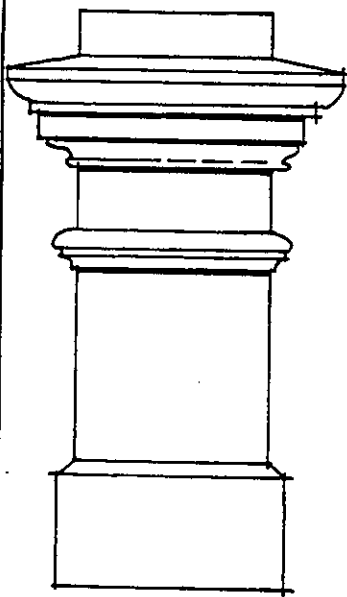
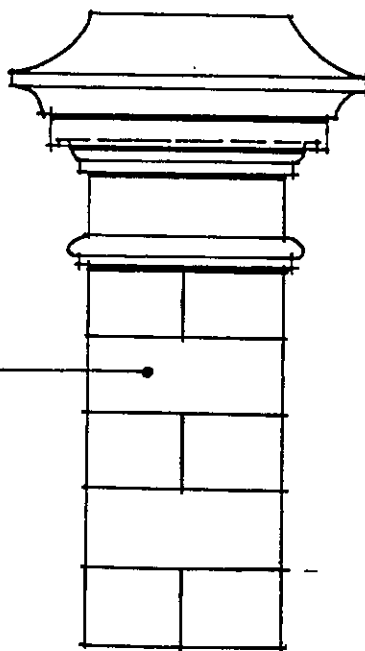
classical

revival

chimney stacks

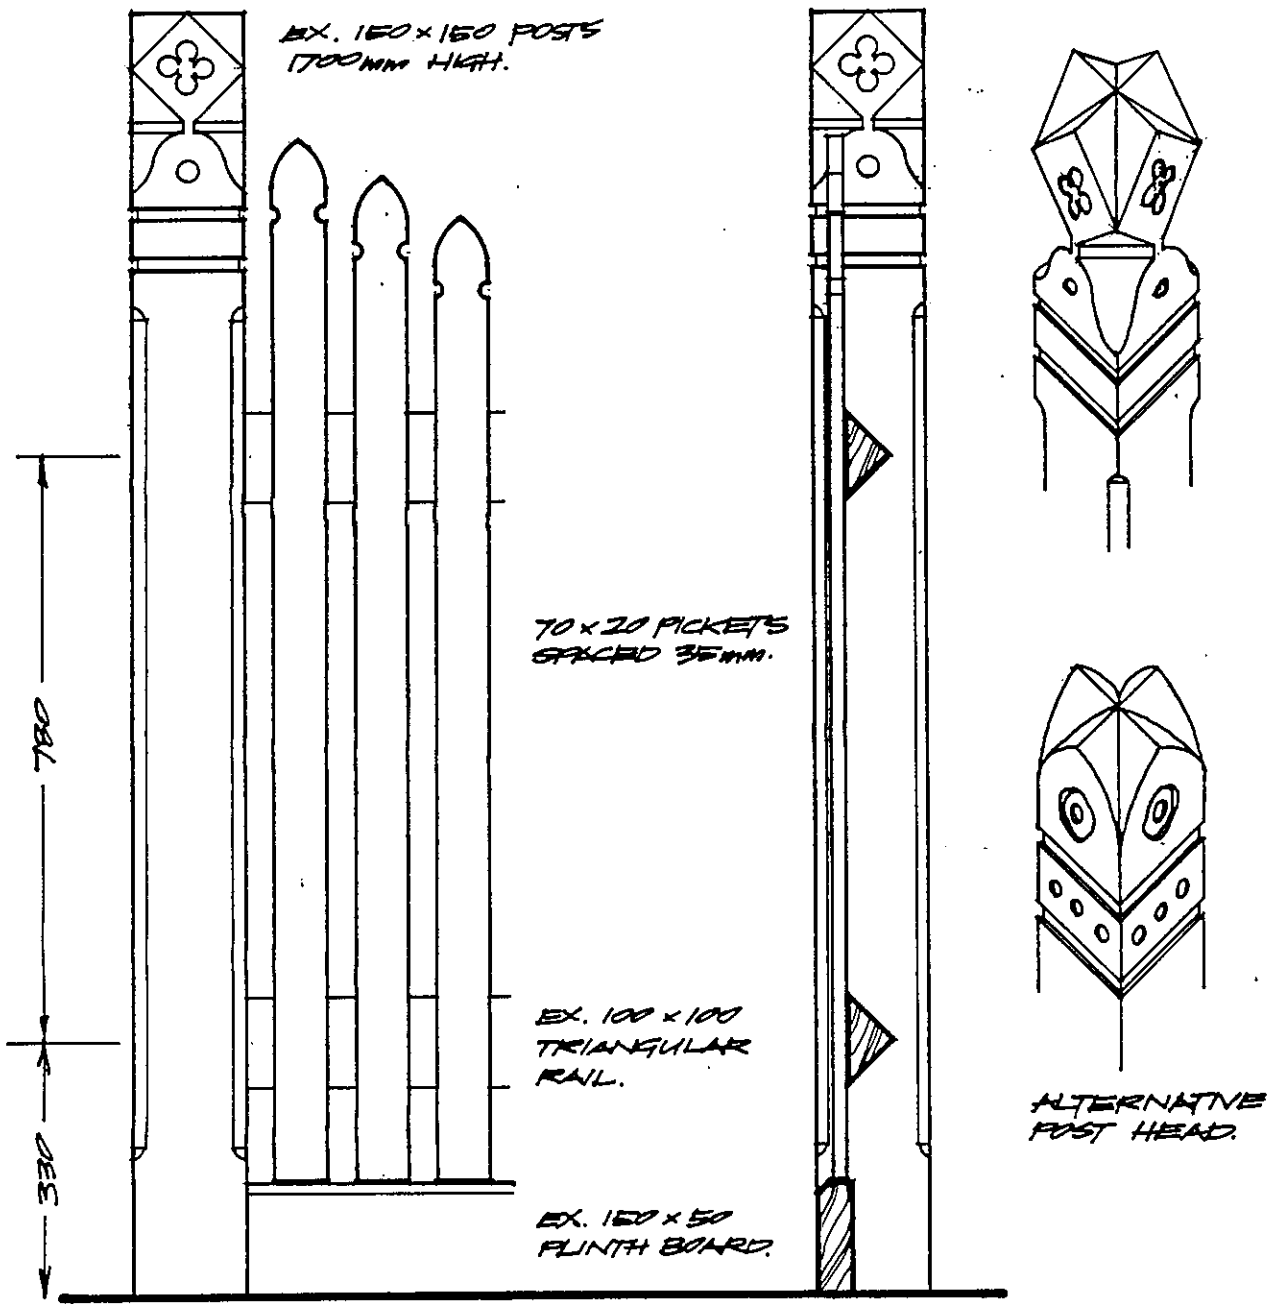
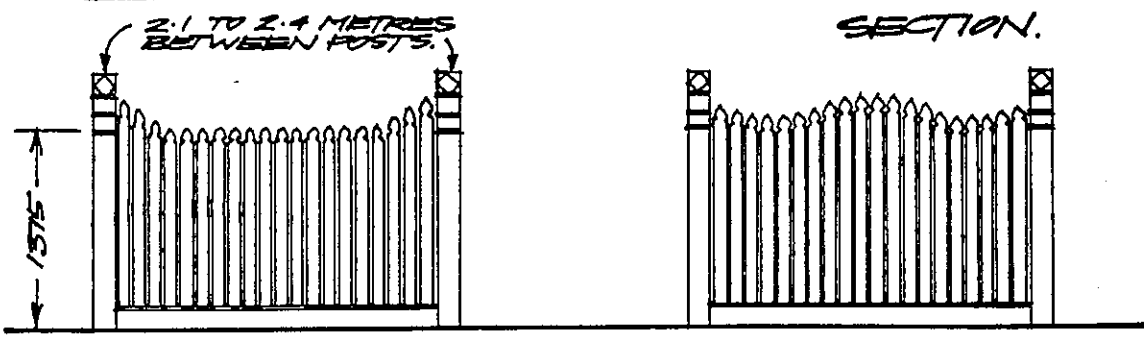
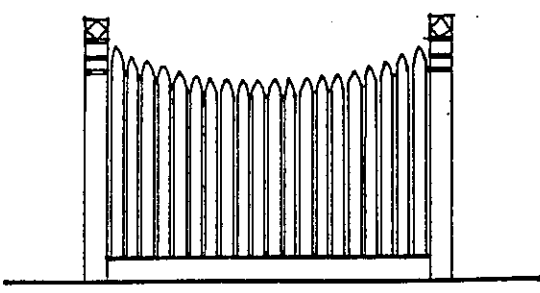
ALTERNATIVE PICKET LAYOUTS.

victorian
fences

The most common form of ornamental front fence was the timber picket fence further enriched with timber gates. Good quality work expressed each vertical timber post as a design element in the fence with horizontal rails checked in. These posts were often elaborately worked with chamfers, rebates, quatrefoil motifs and a variety of terminations. Fence posts were generally 150mm square and the plinth board, always checked into to the post to avoid twisting was invariably 30mm thick and between 130 and 200mm high. Typical vertical dimensions for fence and gate posts were 1.5 to 1.75 metres, the pickets themselves having a line some 1.4 to 1.5 metres above ground level. The pickets were cut to numerous stock patterns, often increasing in height as they approached the fence post or forming a sweeping catenary from one post to the next.

Ledged and braced gates commonly had pickets fixed to them to match the detail of the fence itself. In better quality work, however, the gate was a feature in itself having chamfered rails and styles, vertically or diagonally lined panels and turned timber balusters in the upper portions.

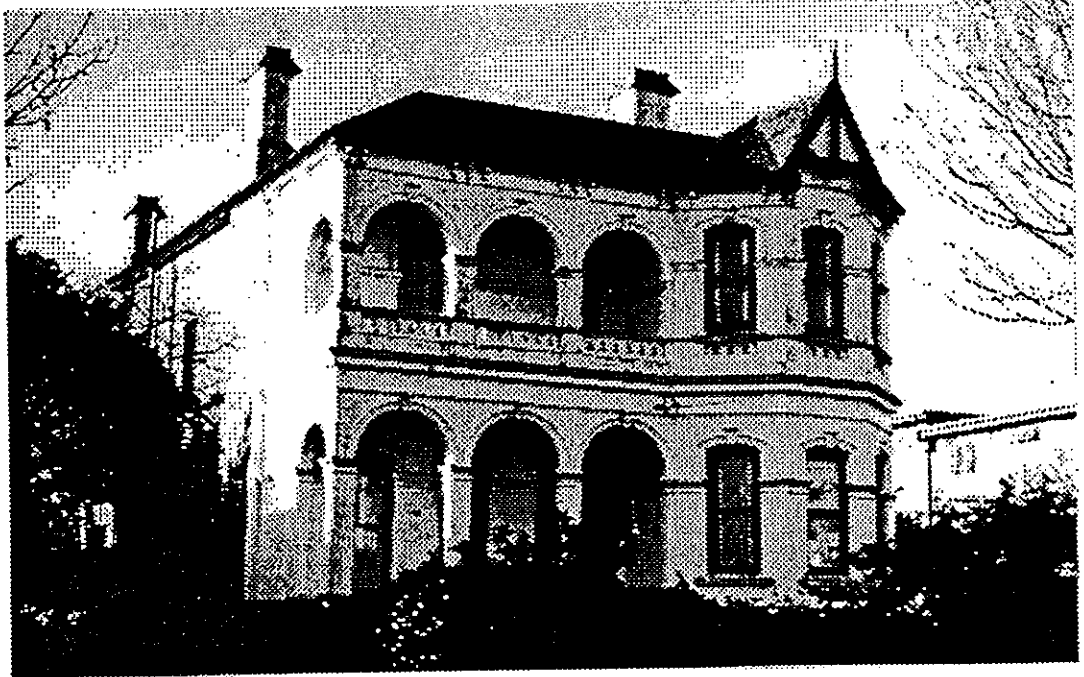
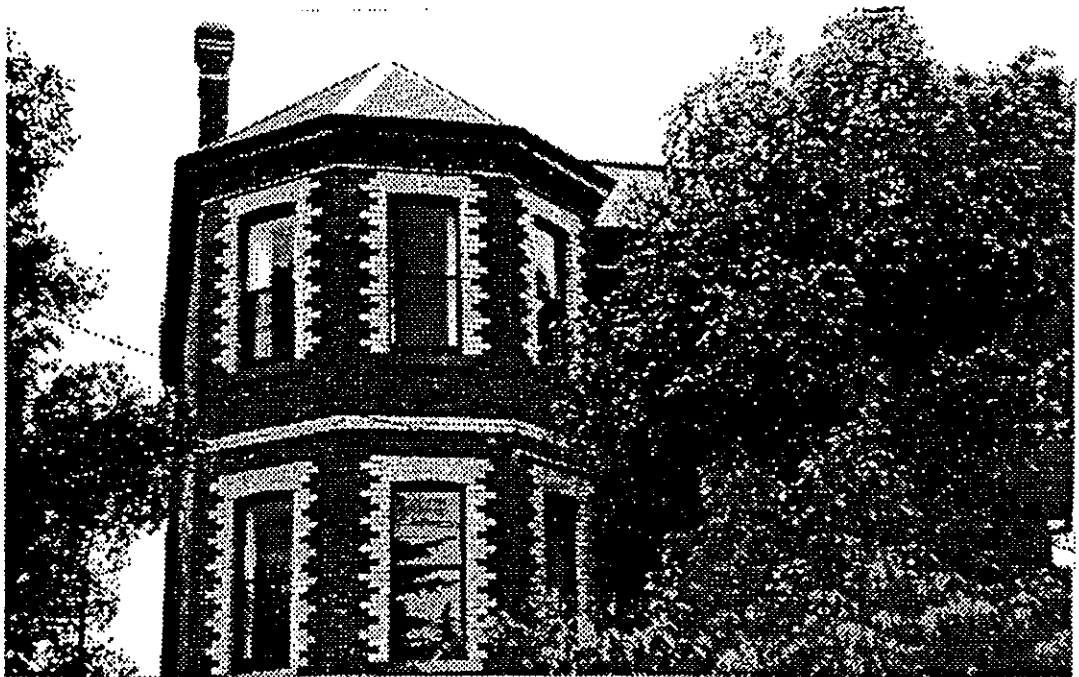
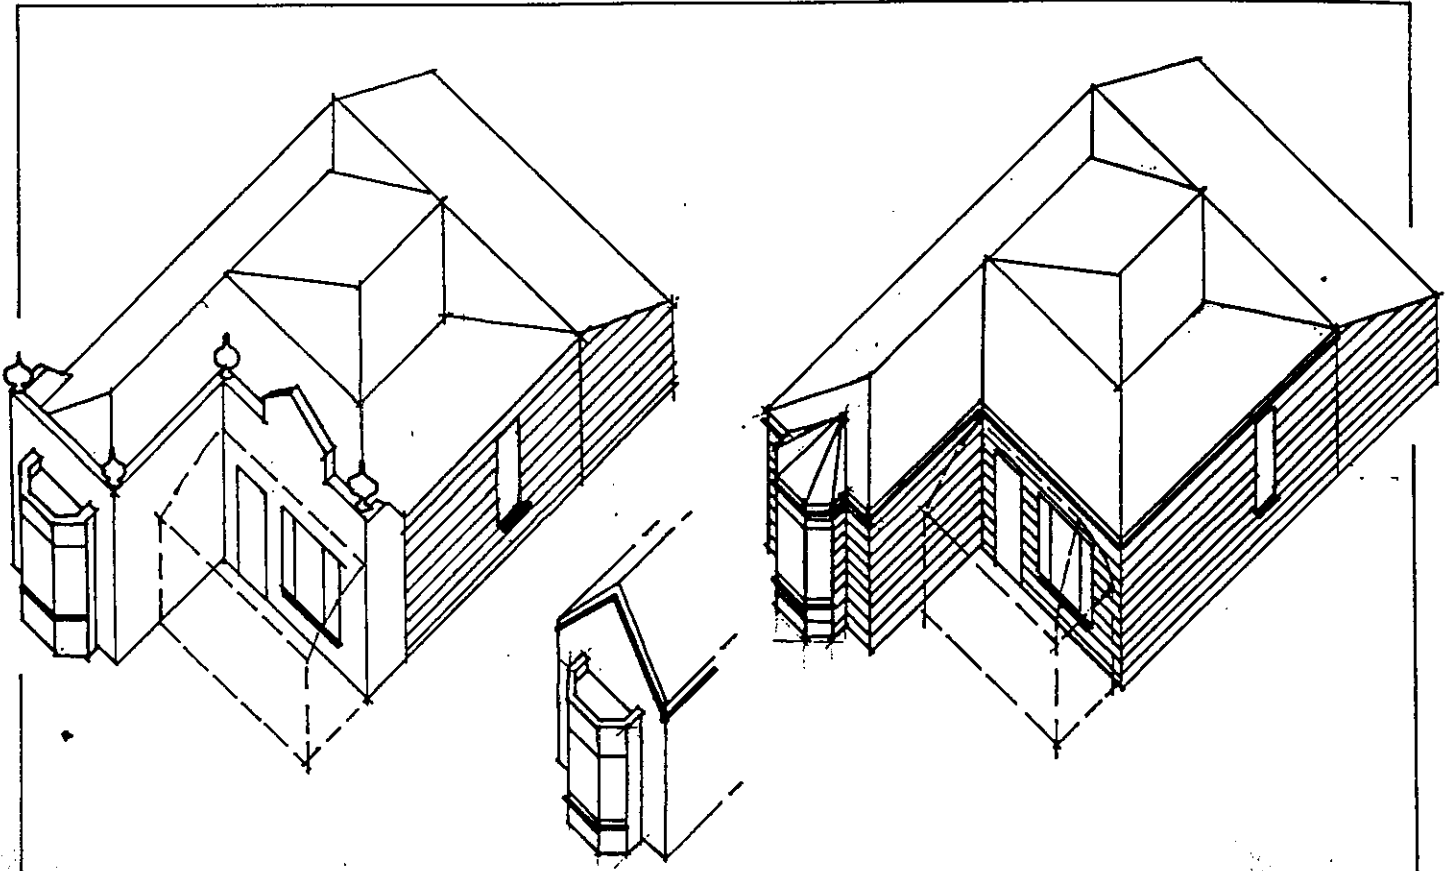
basic italianate villa forms

Architectural form grew out of Classical Revival precedent and became more complex. Distinguishing shapes associated with the Italianate school in Box Hill included the introduction the bay (canted) window, the predominance of the hip and pedimented forms and the introduction of the parapet, associated with the development of the cornice, balustrading and vase like terminations to pilasters.

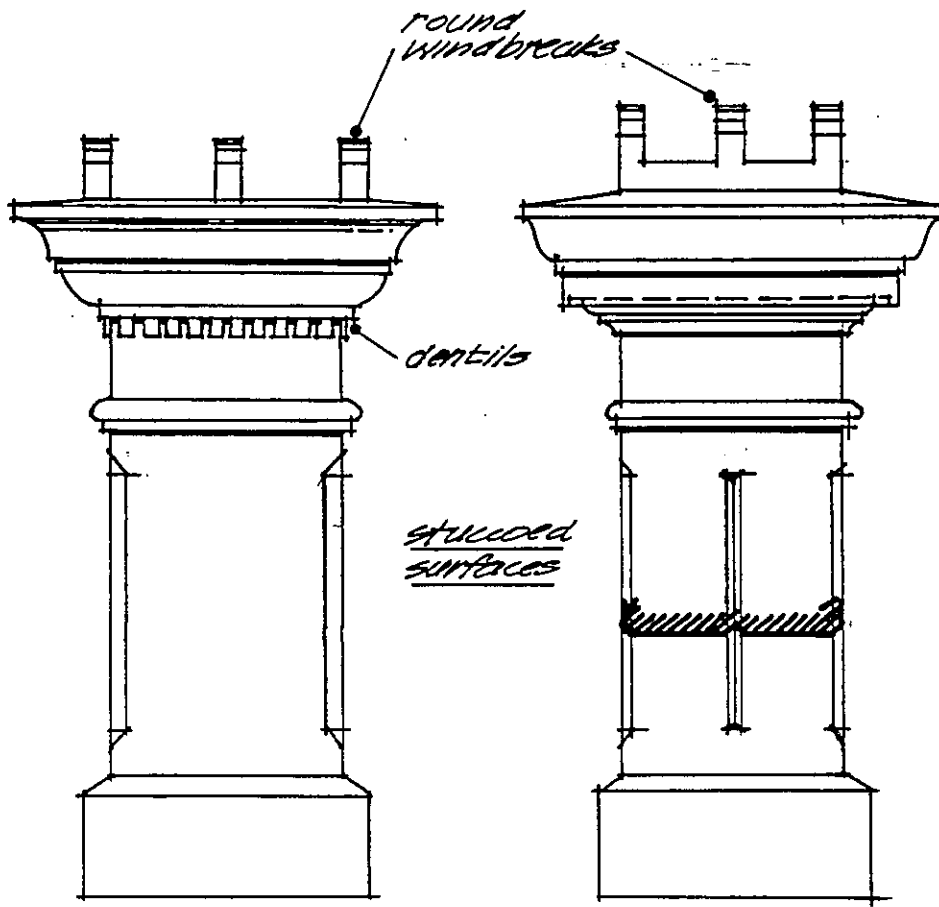
italianate chimney stacks

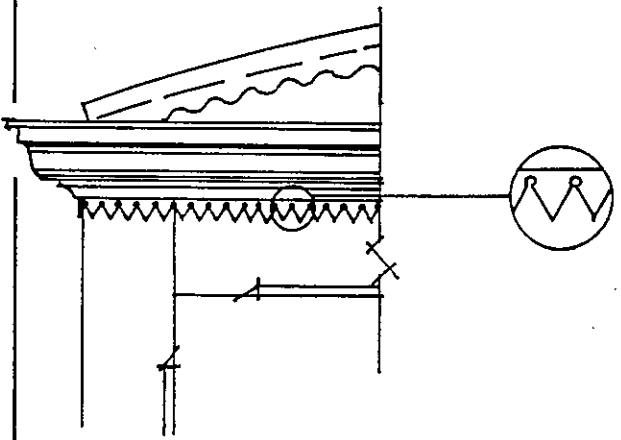
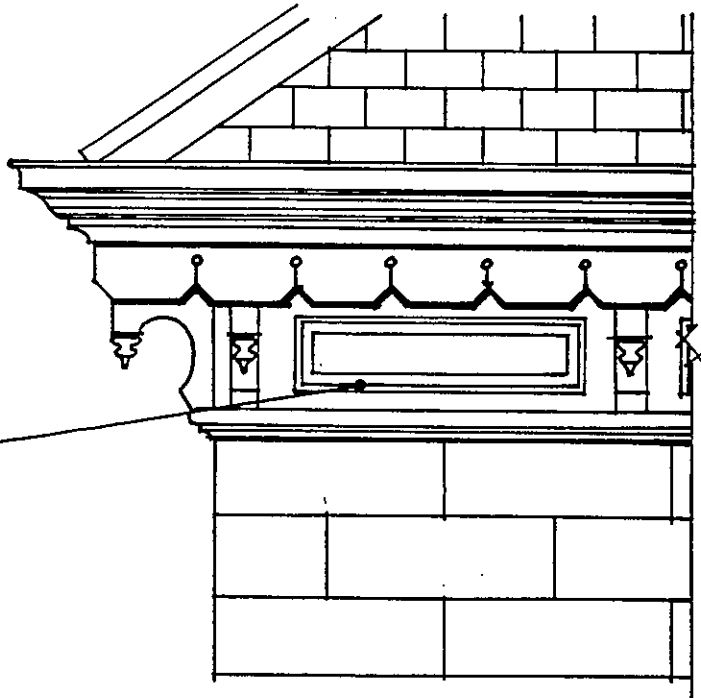
italianate frieze

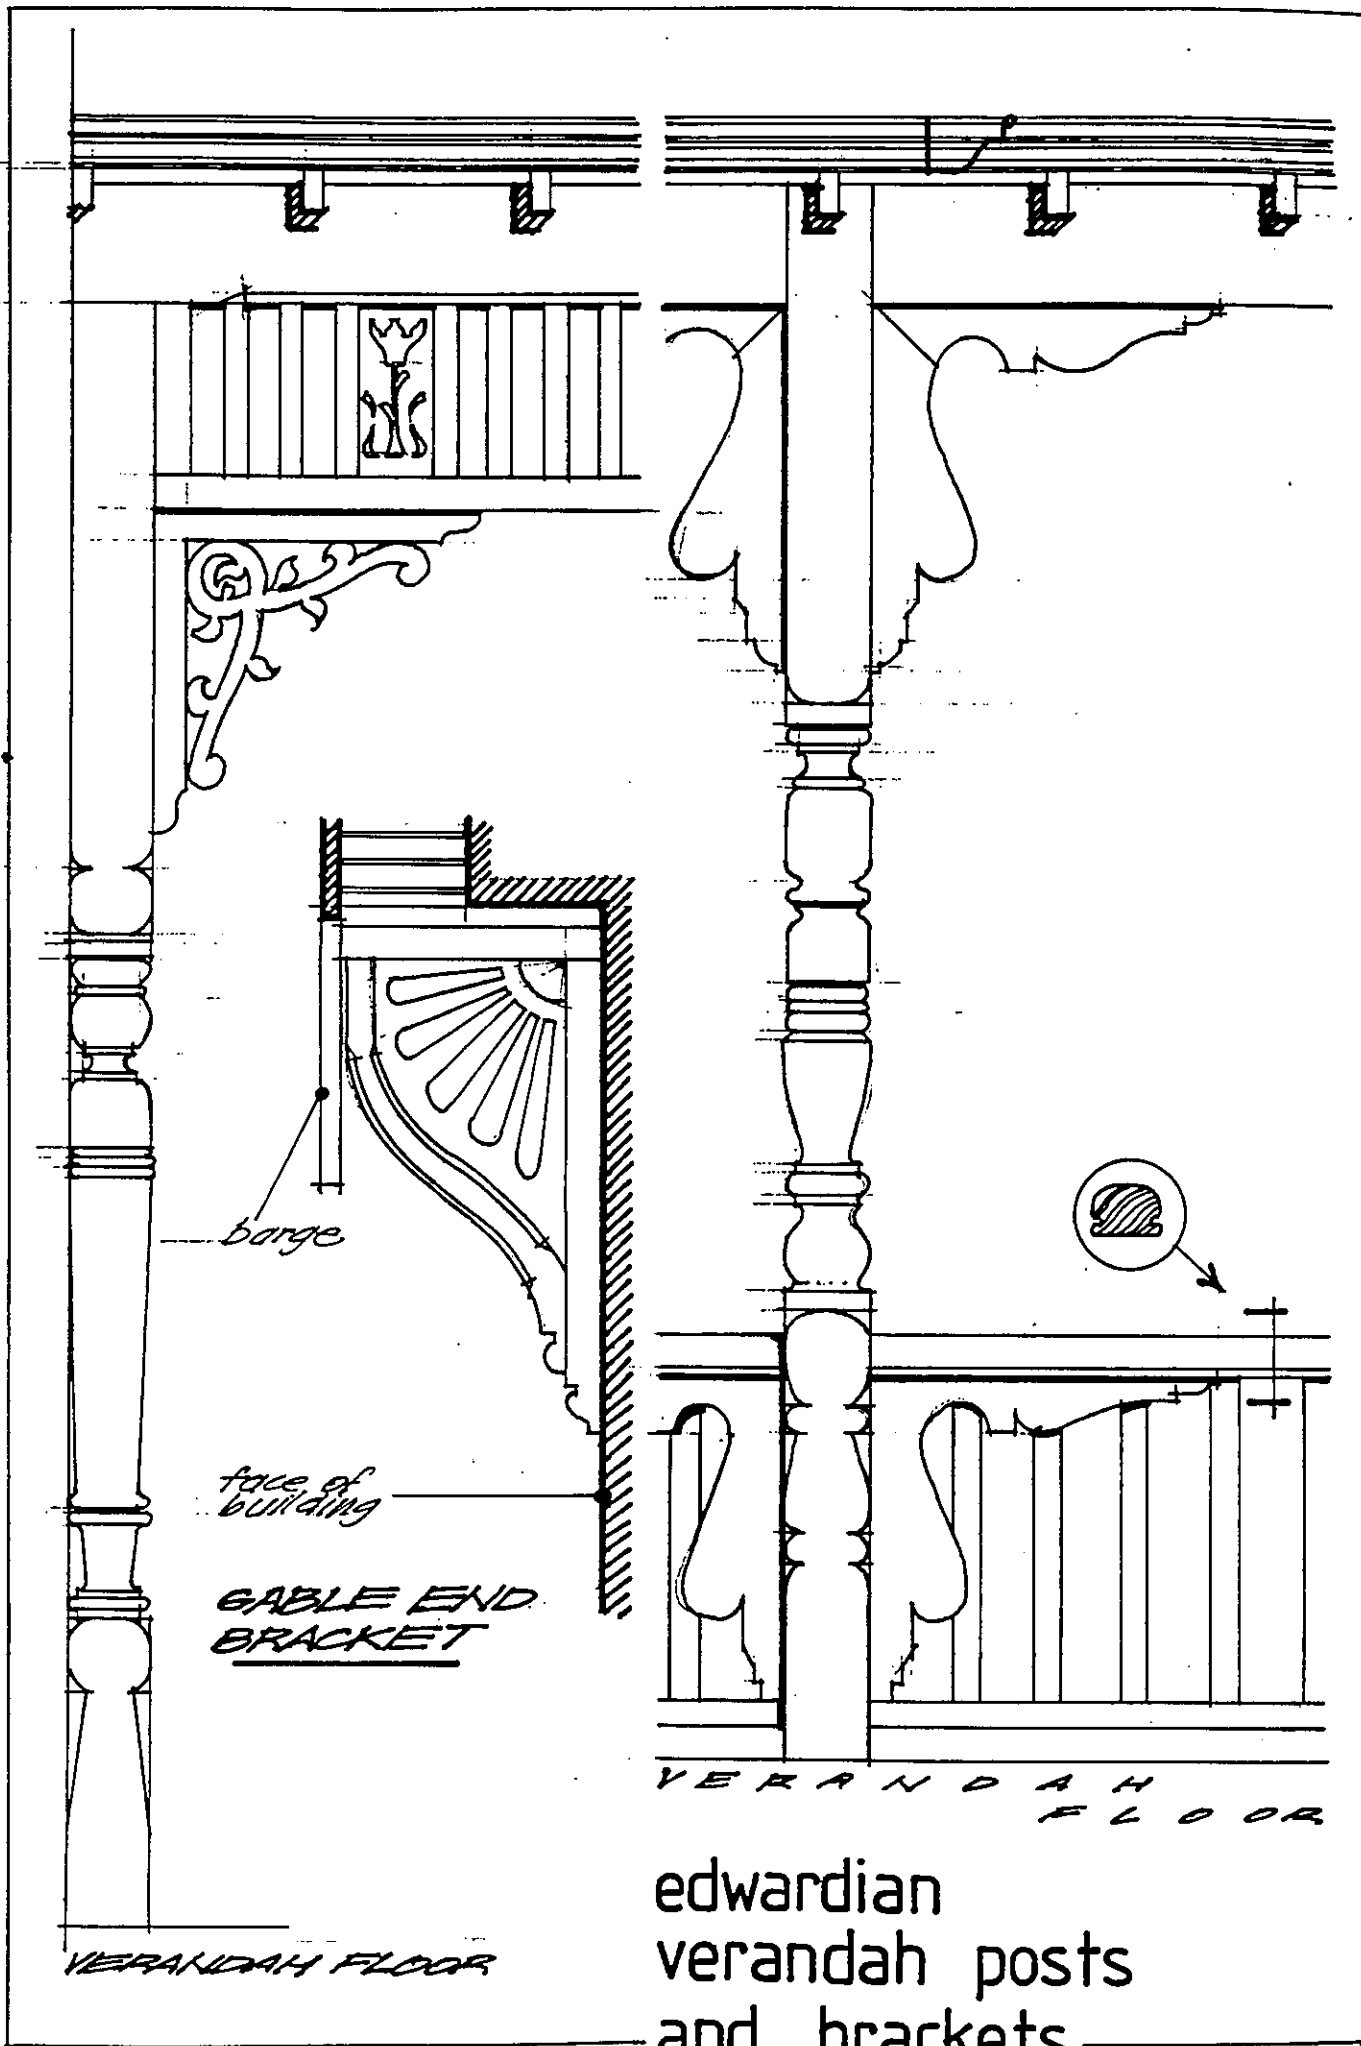
edwardian
verandah posts
and brackets

Verandahs: Verandah friezes and balustrades were heavily influenced by Art Nouveaux motifs including the stemmed leaf symbol cut with a fret saw into narrow battens. Its acceptance in Box Hill was widespread, supplanting the earlier work of the Queen Anne architects who drew for a great part in this area on American precedent.

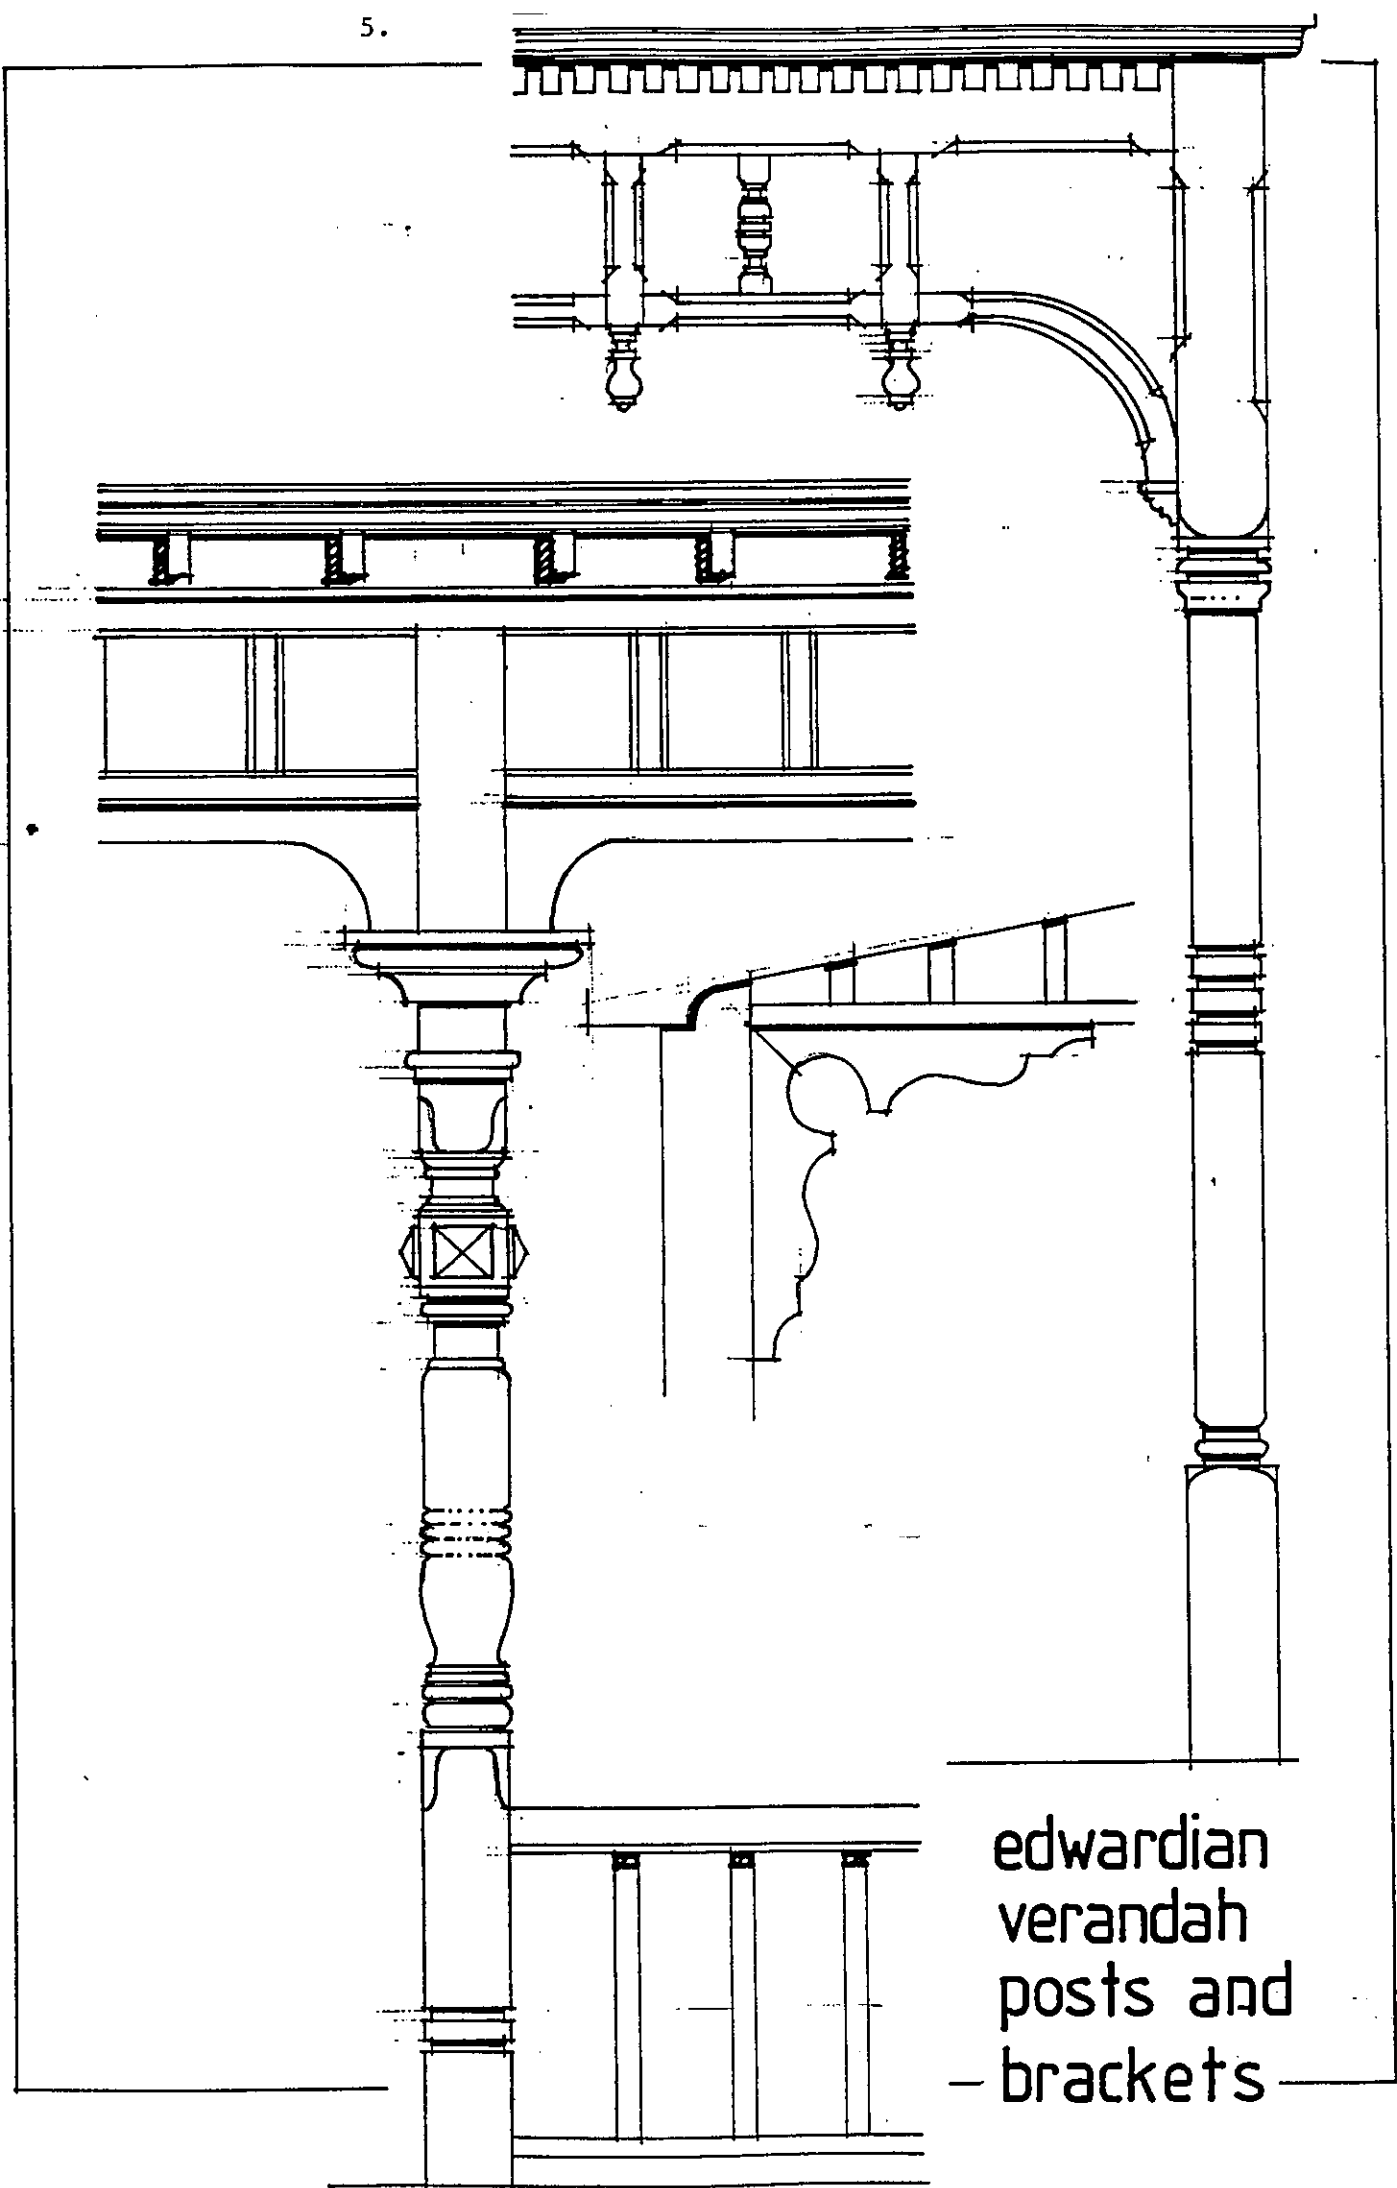
edwardian
verandah
posts and
brackets

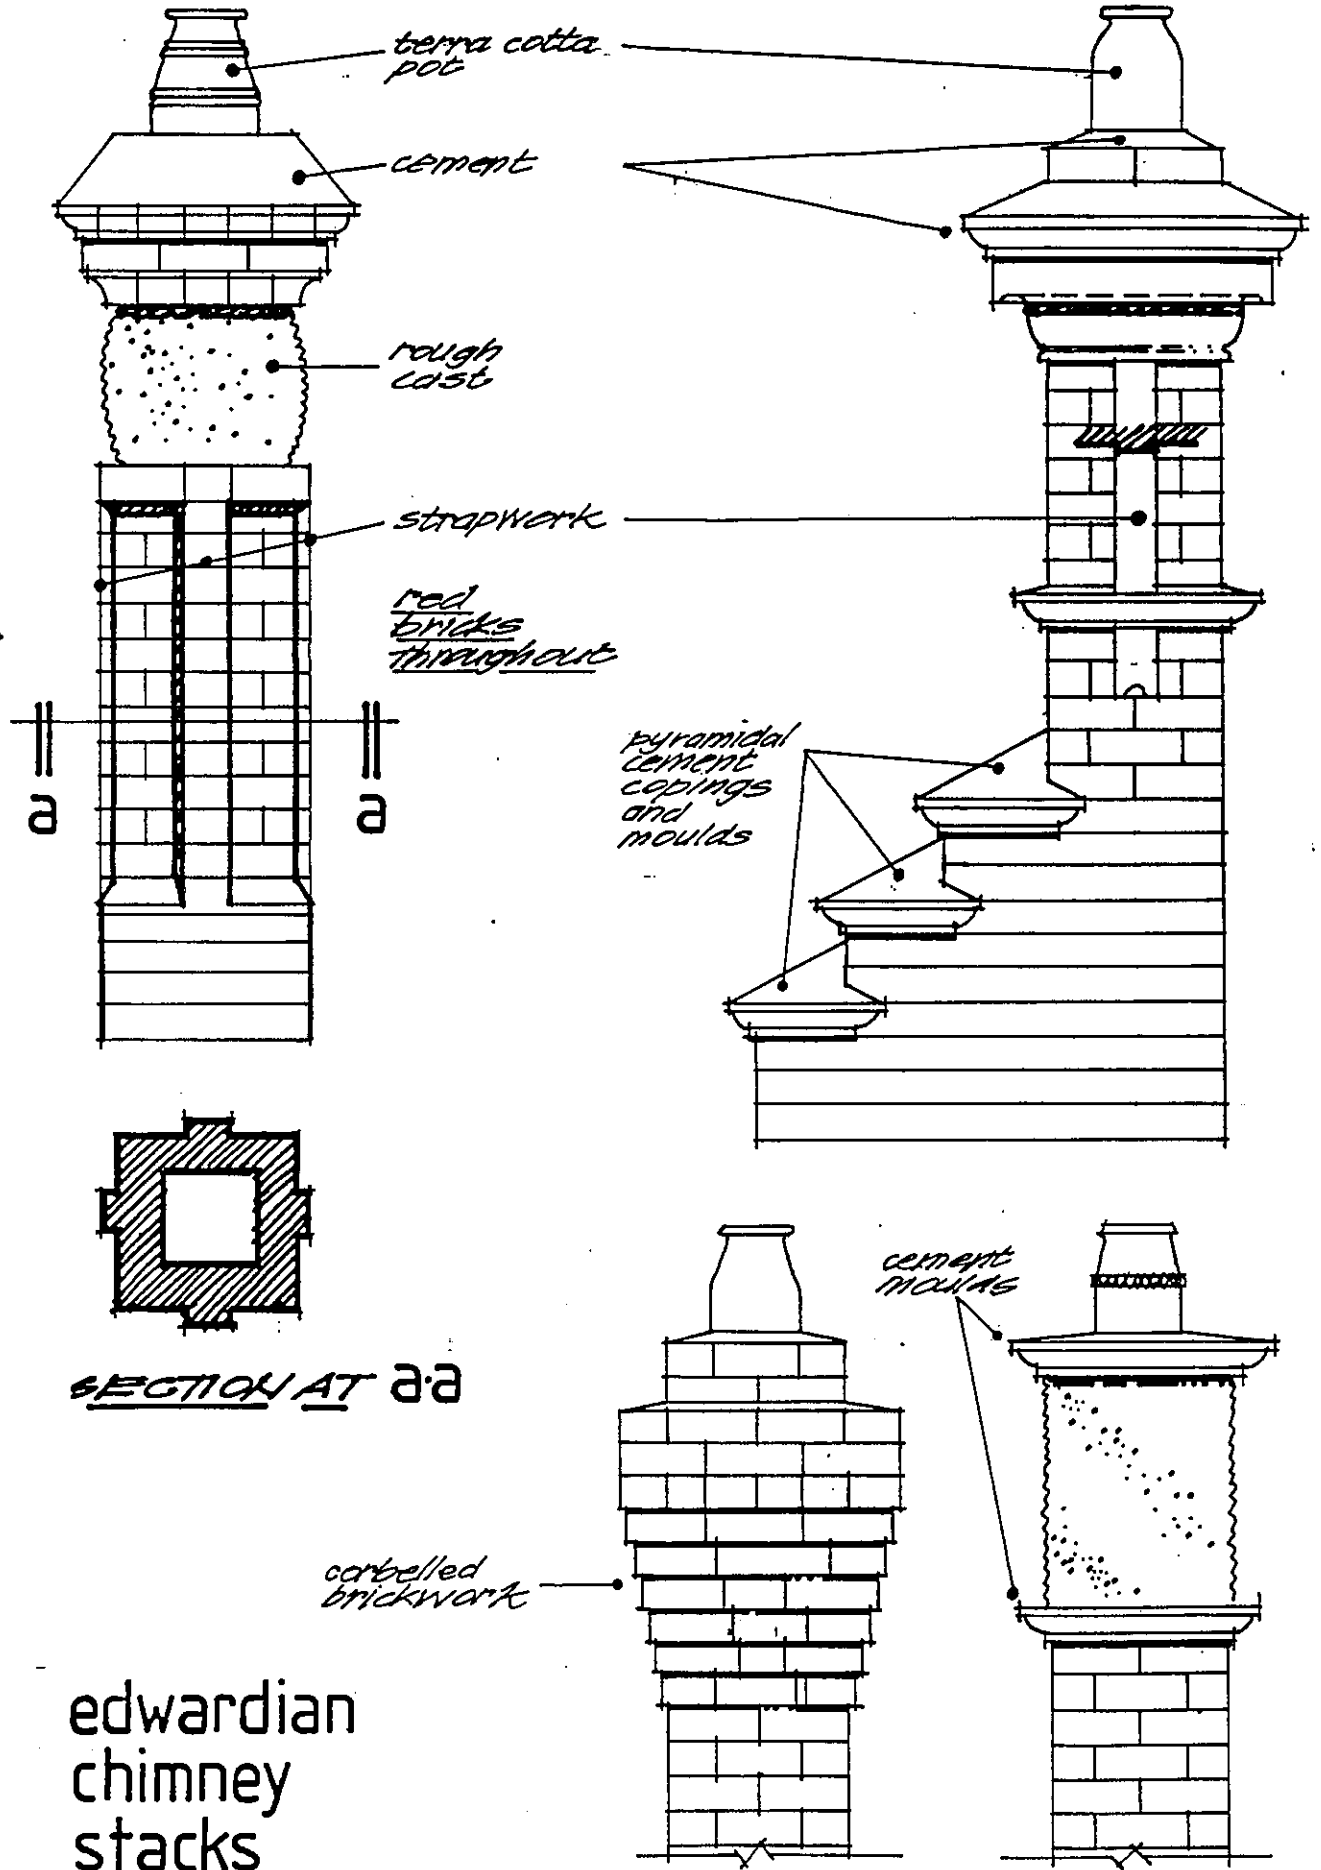
edwardian chimney stacks

Chimney stacks were often tall and compared closely with those of the contemporary Arts and Crafts style. They were typically rough cast and crowned by a 230mm soldier course of bricks or by an over hanging concrete slab surmounted by an undecorated terra cotta pot.

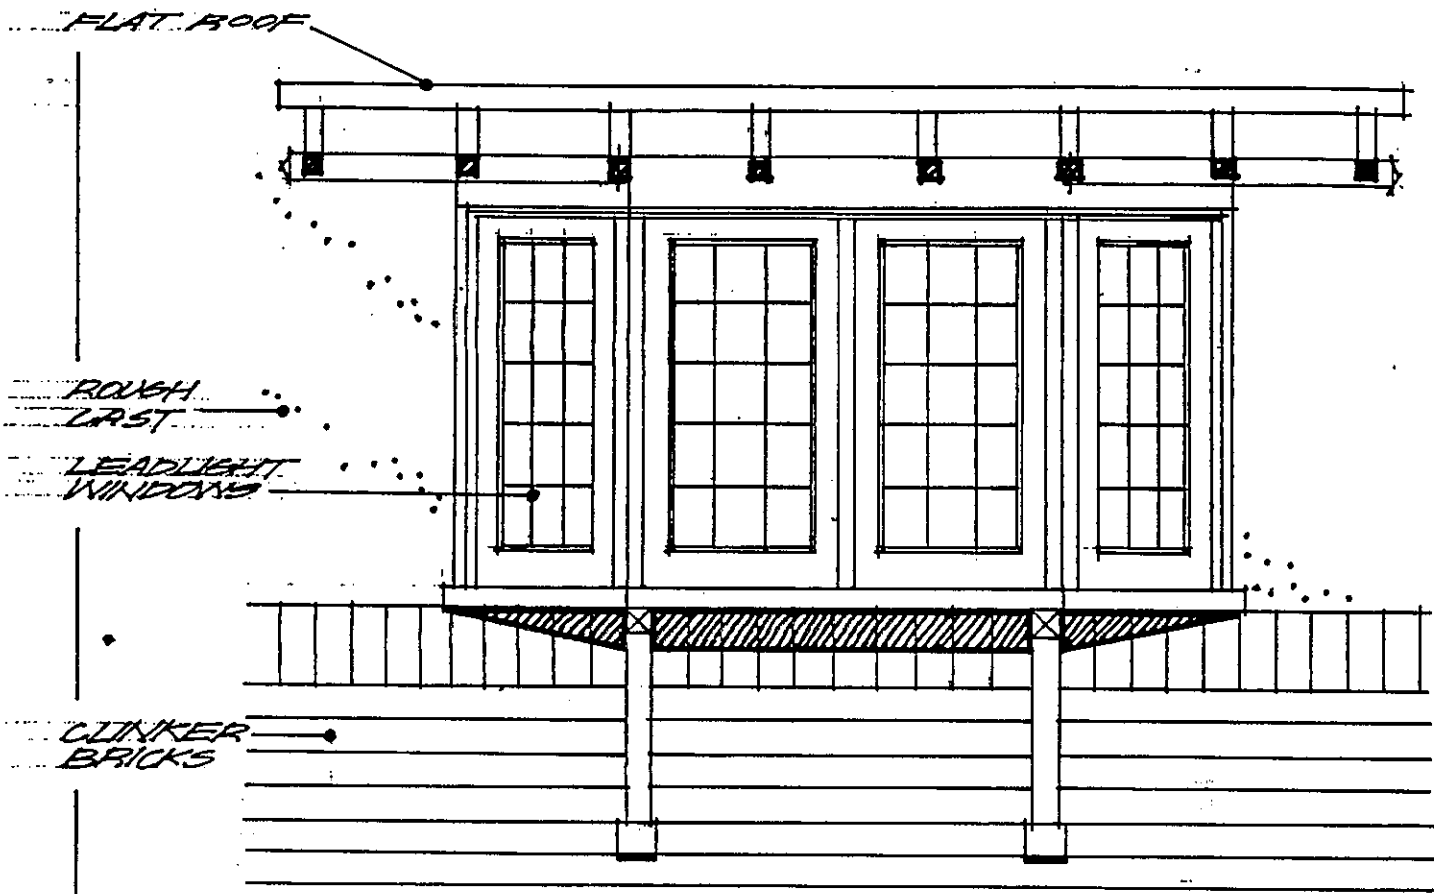
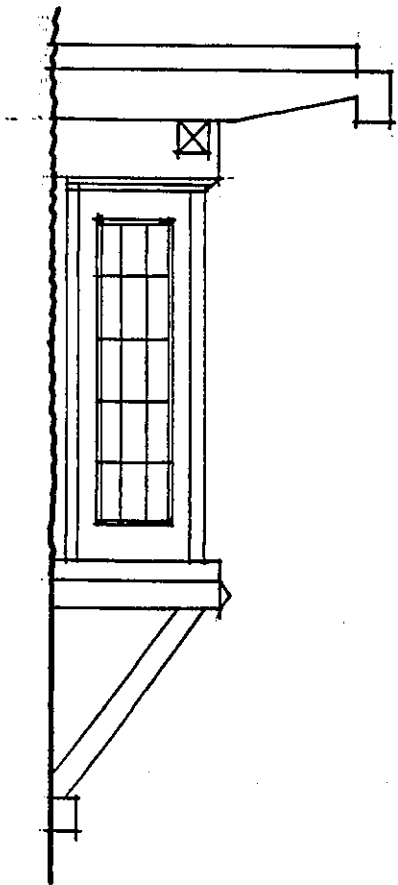
californian bungalow
bay window

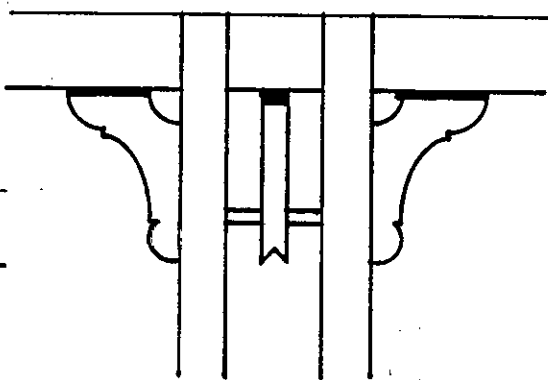
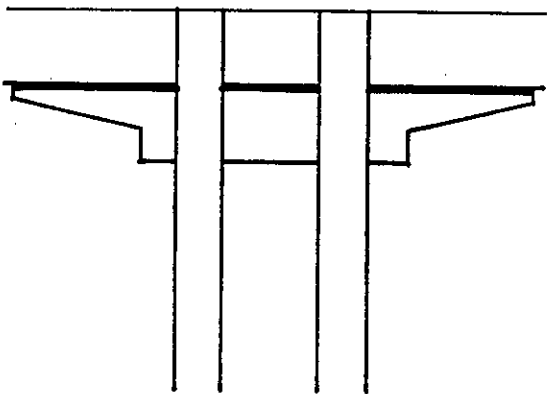
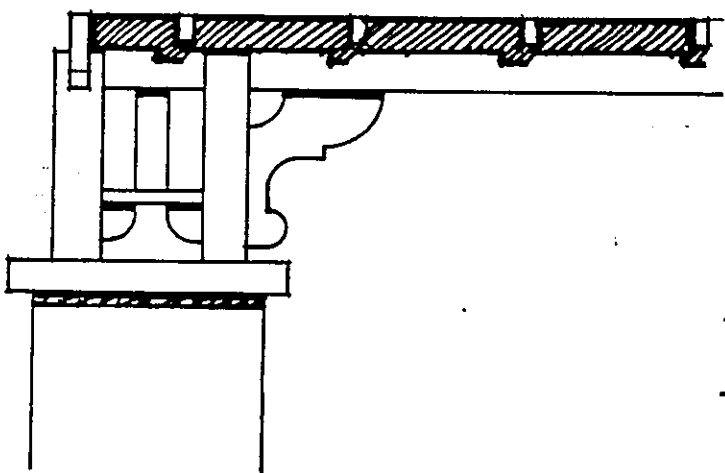
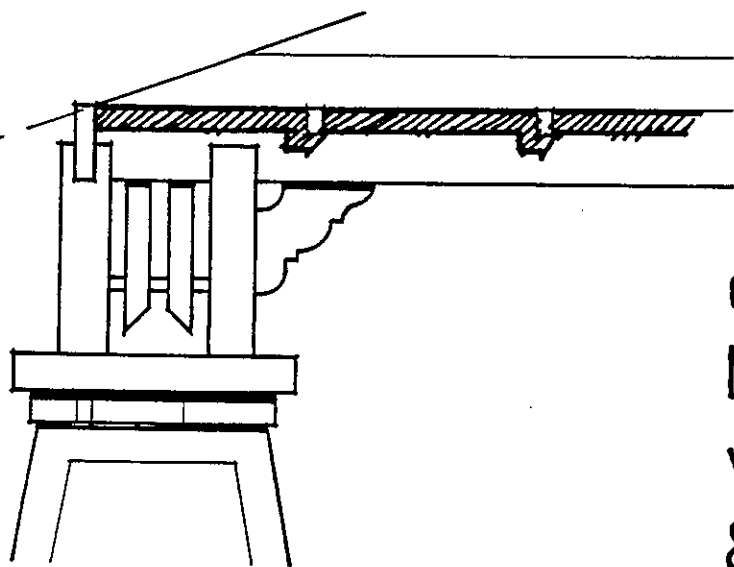
californian
bungalow:
verandah post
& beam details

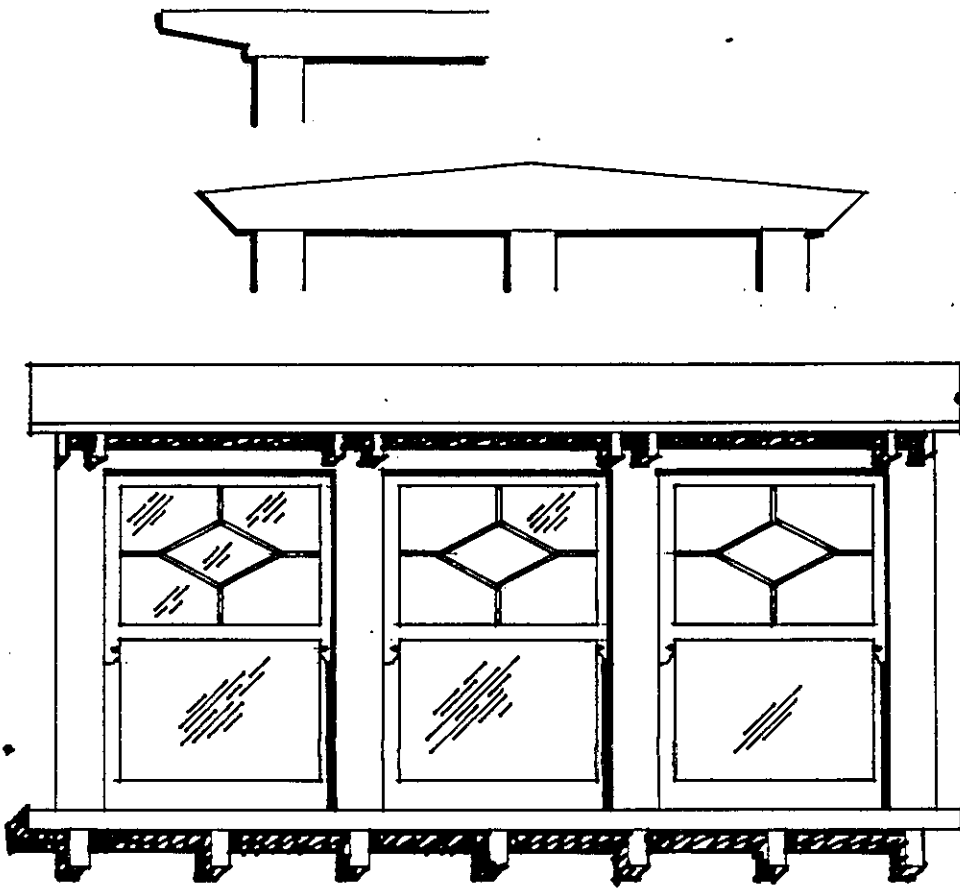
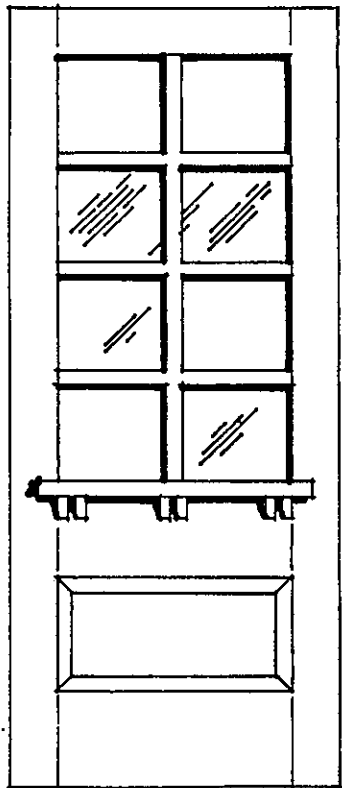
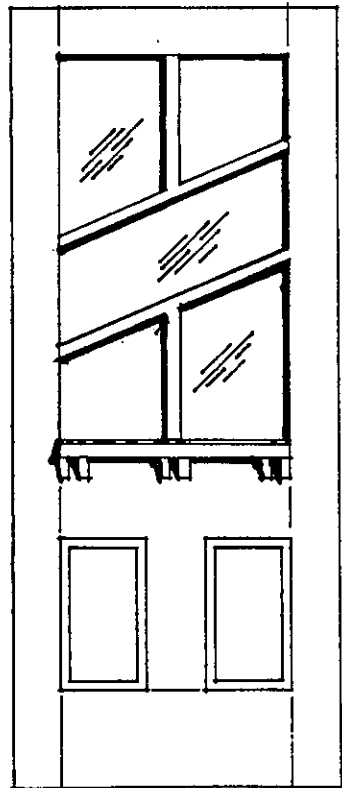
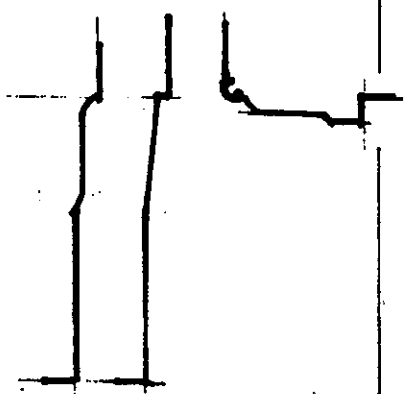
SKIRTINGS
&
ARCHITRAVE

californian
bungalow
window &
door details
