HERITAGE AND CONSERVATION STUDY

VOLUME THREE

CITY OF BOX HILL

**CITY OF BOX HILL
HERITAGE GUIDELINES**

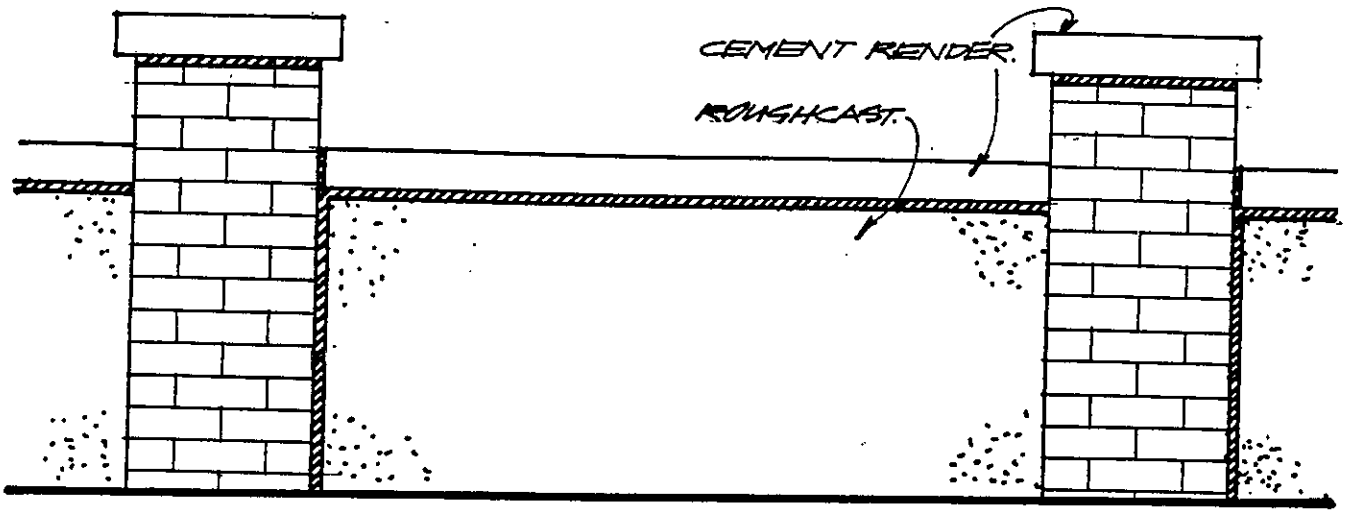
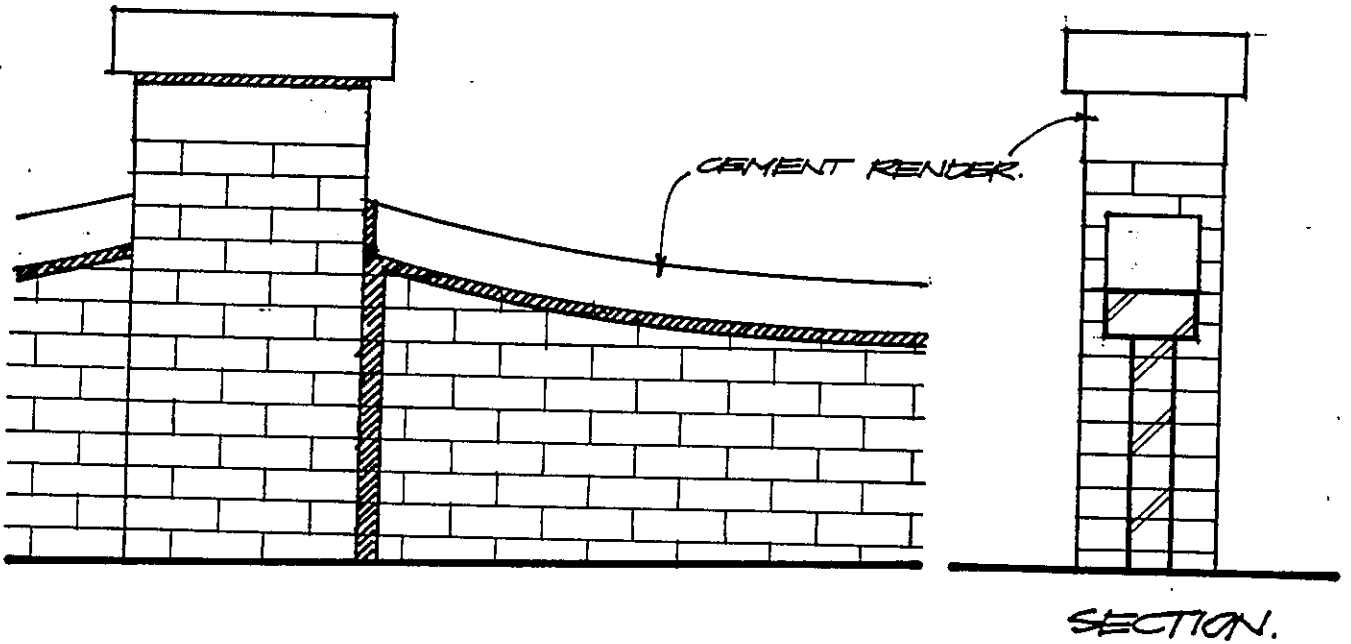
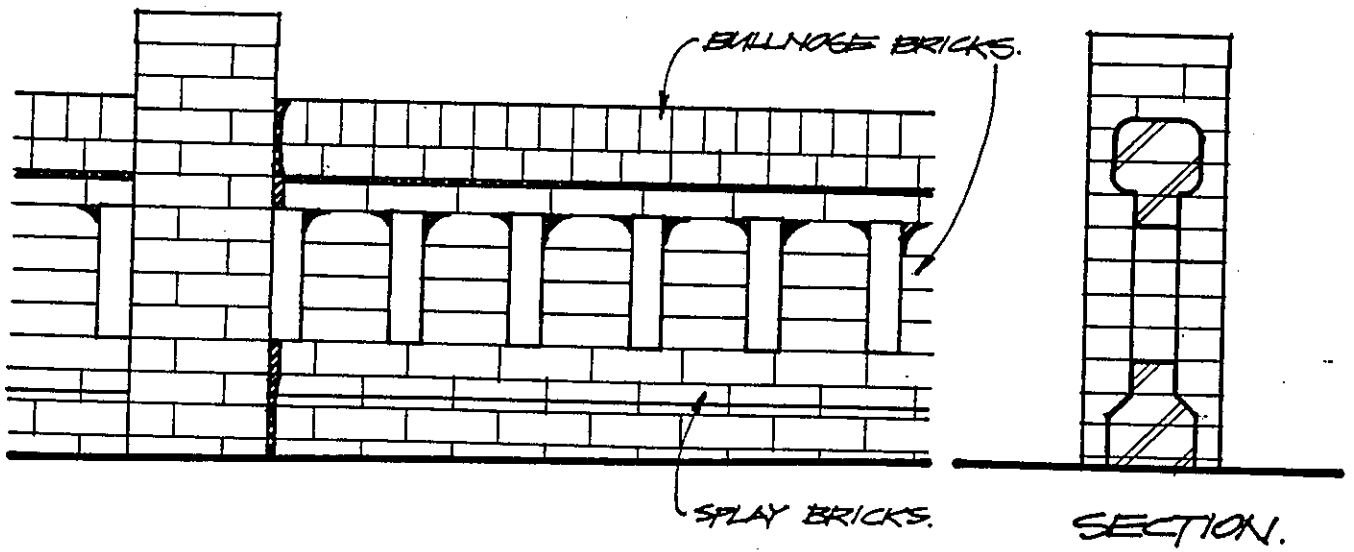
californian bungalow fences

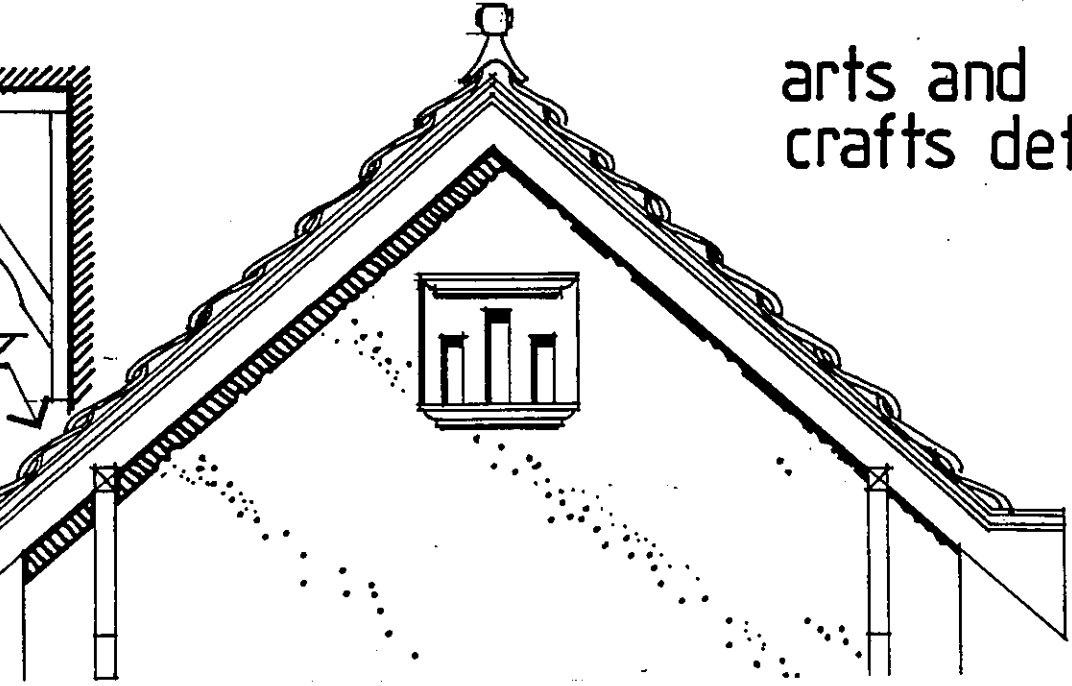
arts and
crafts details

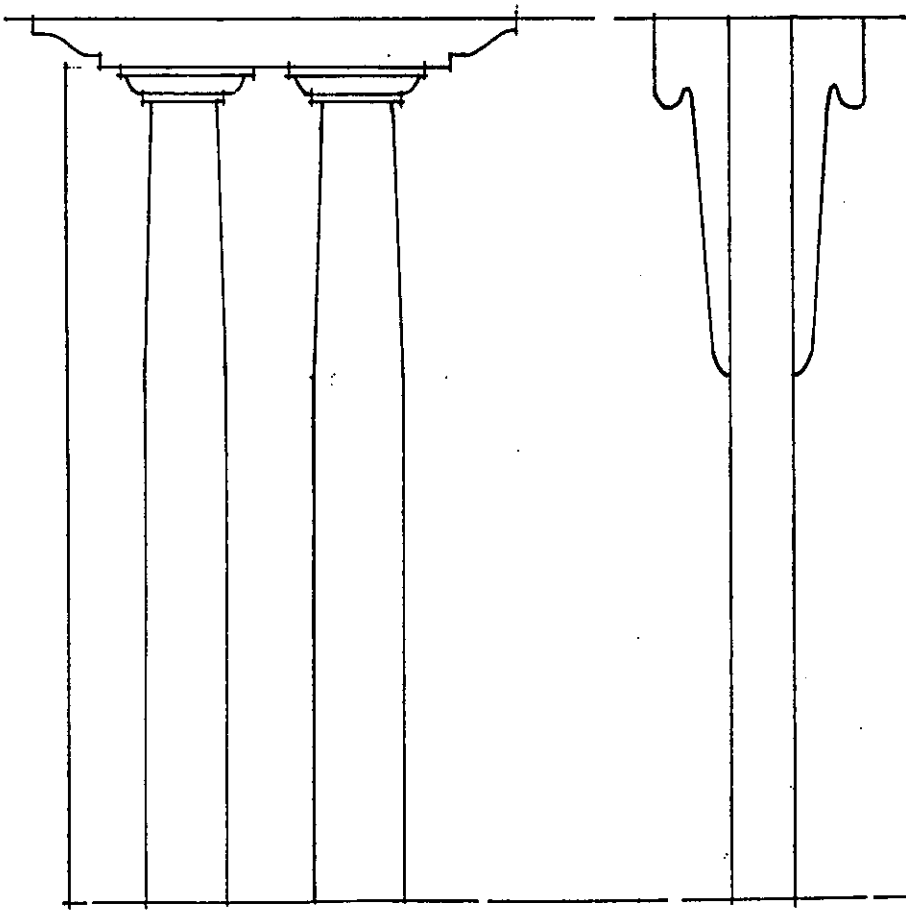
arts & crafts
details

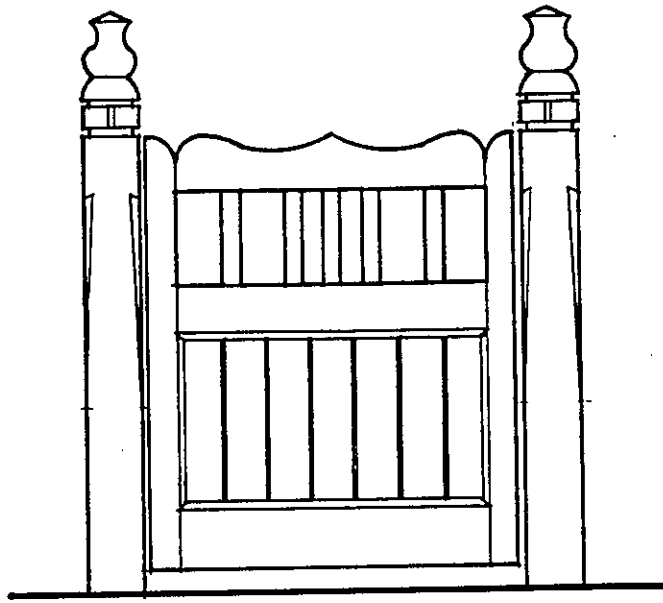
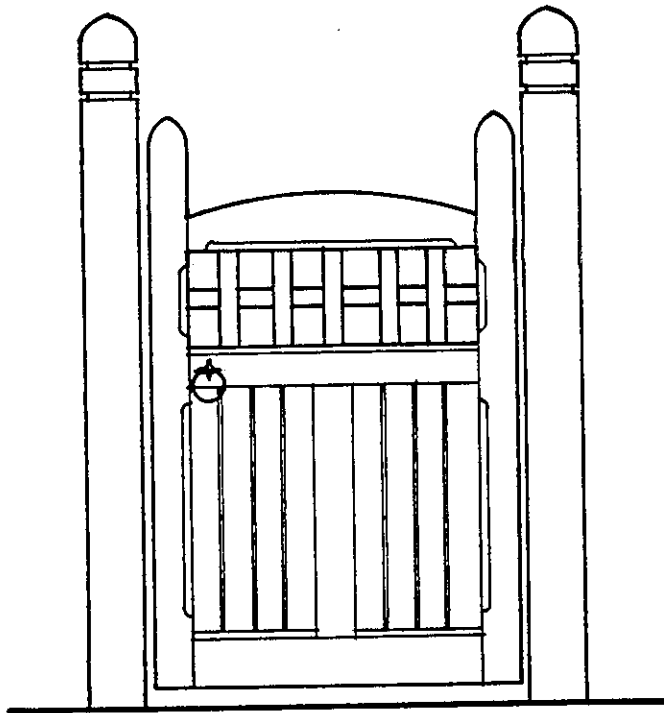
arts & crafts:
gates

Few survive in Box Hill. Although the fences of the contemporary Californian Bungalow are compatible, other types include a low timber framed fence clad with vertical vee jointed linings and capping rail. The height of the fence might be extended by a continuous strip of square lattice work finished with another capping rail, the effect being complete with a cypress hedge. Volcanic rock fences are also characteristic. Curiously, a small number of timber gates and gate posts survive in the municipality, the illustration being representative. Picket fences incorporated wide pickets with flat tops and motifs cut out of the picket head.
