PLANNING PANELS HEARING

Amendment C230whse

490-500 BURWOOD HIGHWAY, VERMONT SOUTH

PREPARED FOR DANDENONG VIEWS PTY LTD INSTRUCTED BY NORTON ROSE FULBRIGHT SITE INSPECTION 10 JANUARY 2023

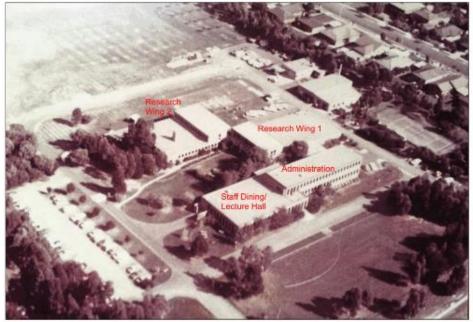
Figure 5

Aerial photograph identified as 1975 in the Raworth CMP but, given tree sizes, possibly up to a decade later.

9.14 The 1975 aerial photograph of the ARRB site, Figure 5, reveals how fast the native trees planted to the northern end of the site grew and it is hard to understand how the planting of these trees may not pre-date the construction works. The notable feature of this photograph is that planting extending along the north, west and east boundaries reveals nothing innovative in terms of landscape design; native trees planted *en masse* have created a screening to the site boundaries, a treatment that is widely used and shows little in terms of innovative design.

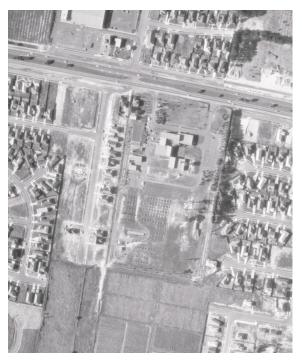
Figure 6

Aerial photograph appears to show no landscape in place to south of Administration Building, given that Mann retired in 1976 this must have been one of her last projects and the image proves an incorrect dating for Figure 5.

9.15 Landata photographs of the site support the view that the photograph ascribed in the CMP to 1975 is of later origin. The 1975 Landata image, Figure 6, suggests that planting may not have occurred until 1976 or 1977 but it had certainly grown by 1981, Figure 7.

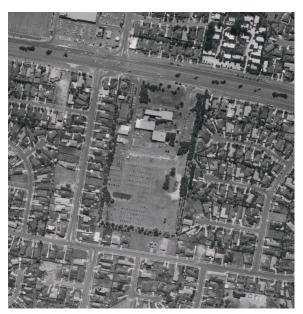
A 1981 aerial photograph shows the planting making a significant visual impact. Growth of native trees was very rapid with planting likely taking place in the winter of 1975 or 1976.

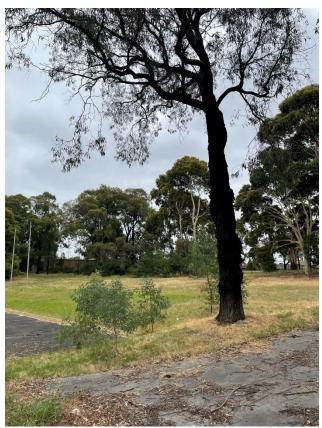
Figure 8

View of the northern lawn and Burwood Highway planting, January 2023.

9.16 Much of the planting to the northern portion of the site, much of it in the Burwood Highway frontage, remains in place as does the large open lawn beyond the access road. The ARRB Administration building is scarcely visible when viewed from the west especially since the construction of the sub-station to the north-west of the site, though the more open planting to the eastern portion of the frontage permits views of the façade. This grouping of trees with the open lawn to its south and the façade behind provides an appropriate public presentation of the facility.

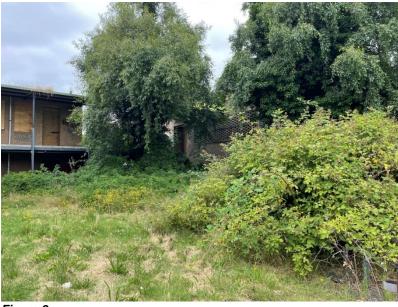
Figure 9

9.21 A review of this area at the present time reveals that it is quite derelict and has been overgrown with weeds. Two mature evergreen Mexican Alders, *Alnus jorullensis*, trees 150 and 151, are located to the façade of the Administration building to the west of the space. It is difficult to determine whether these are original planting. The 1975 image shows tree canopies above roof height suggesting very rapid growth. These trees became fashionable in Melbourne towards the second half of the 1970's and the specimens present are senescent.

Internal courtyard to south-east of Administration Building. Weed growth disguises the simple and functional planting lay out, January 2023.

- 9.22 The courtyard also includes weedy trees including a number of Sweet Pittosporum, *Pittosporum undulatum*, tree 141, Shiny Leaved Privet, *Ligustrum lucidum*, tree 144, Cotoneaster, *Cotoneaster glaucophyllus*, tree 143, Desert Ashes, *Fraxinus angustifolia*, trees152 and 153, though judging from the photograph these appear to be original planting, and Box Elder, *Acer negundo*, unnumbered. These outnumber what may be original plantings including Willow Hakea, *Hakea saligna*, trees146-149, which may be self-propagating, Gossamer Wattle, *Acacia floribunda*, tree 145 and Heath Banksia, *Banksia ericifolia*, tree 142.

- 9.23 There is no sense that this courtyard has been designed to offer any more than a basic peripheral landscape planting with the creation of a lawn and the provision of a barbecue. It is difficult to ascribe heritage significance to such a landscape space even allowing for its contribution to the architectural built form with construction around light courts.

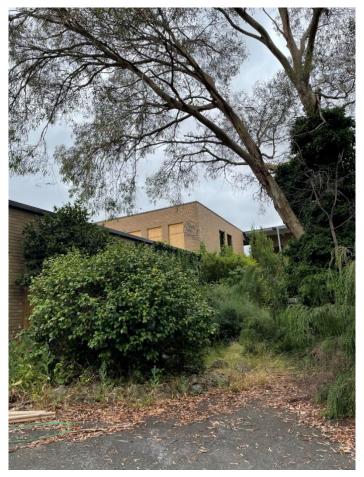
Figure 10

Planting between Research Wings 1 and 3 post-dates Mann's involvement, January 2023.

- 9.26 Planting in the space between Research Wings 1 and 3 is more complete than that to the east of Research Wing 1 and includes two mature Eucalypts, Yellow Gum, *Eucalyptus leucoxylon*, trees 178 and 180, hedges of Coastal Rosemary, *Westringia fruticosa*, plantings of Japanese Camellias, *Camellia japonica* and a feature Ovens River Wattle, *Acacia cognata*. Sweet Pittosporums contribute significant canopy to the eastern portion of this space which remains dominated by angled car parking, a treatment visible in the aerial photograph. Other trees present here include Spotted Gum, *Corymbia maculata*, tree 179 and Red Spotted Gums, *Eucalyptus mannifera*, trees 176 and 177. All have shown rapid growth.

9.25 Beryl Mann retired in 1976 and there would appear to be no definitive proof that she designed this garden area. It is possible that she prepared plans for this area to be implemented when construction of Research Wing 3 and the Truck Bay took place but it would be equally valid to suggest this was designed by another, currently unidentified, designer at the time of construction, 1986.
