TREE MANAGEMENT PLAN REVISED MARCH 2019

160 WHITEHORSE Rd BLACKBURN

MARCH 2019

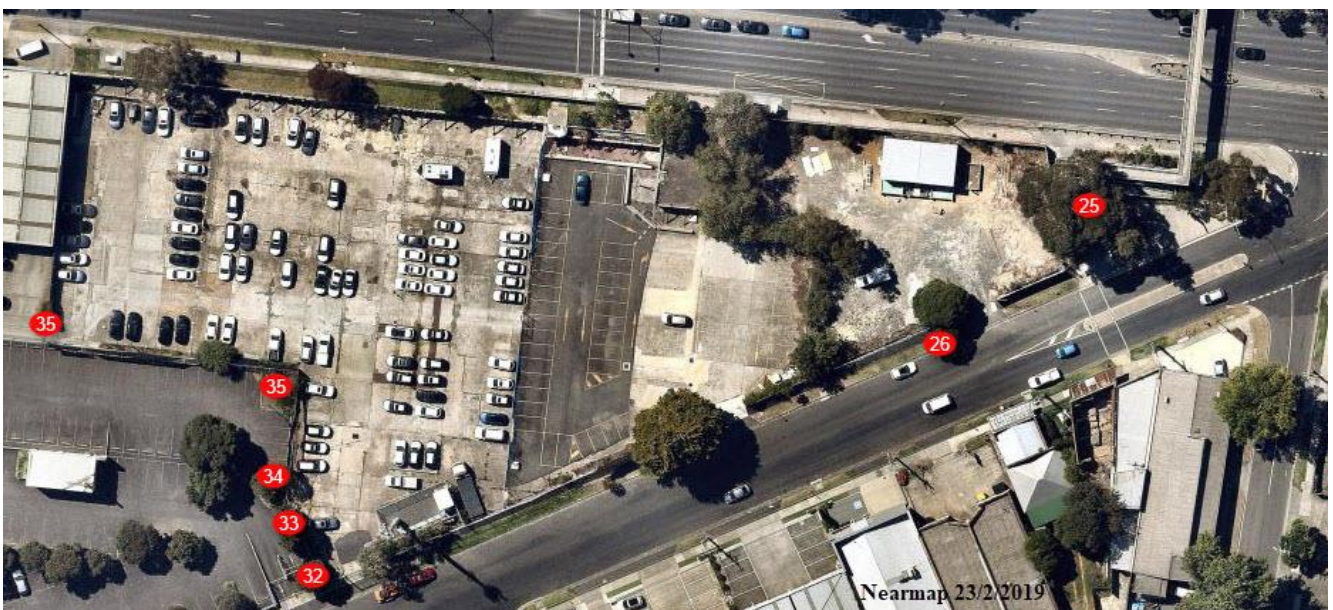
1. **Location:** 160 Whitehorse Rd Blackburn
2. **Prepared By:** Leigh Stone
Associate Diploma of Applied Science (Horticulture) – Arboriculture
Bachelor of Applied Science (Horticulture)
3. **Date of Plan:** 16/3/2017
4. **Purpose of Plan:**
 - 4.1. To provide a Tree Management Plan for 7 trees adjoining the subject property in view of a commercial development on the subject property, in response to the request outlined in Conditions of the Planning Permit WH/2017/277 from the City of Whitehorse. See **Photograph 1** below.
