E Existing Conditions Reviews

WHITEHORSE CENTRE BUSINESS CASE – STRUCTURAL ENGINEERING REVIEW

Date: 23 August 2013
Project No: 12ME0460
Client: Williams Ross Architects

DOCUMENT & EXISTING
CONDITIONS REVIEW

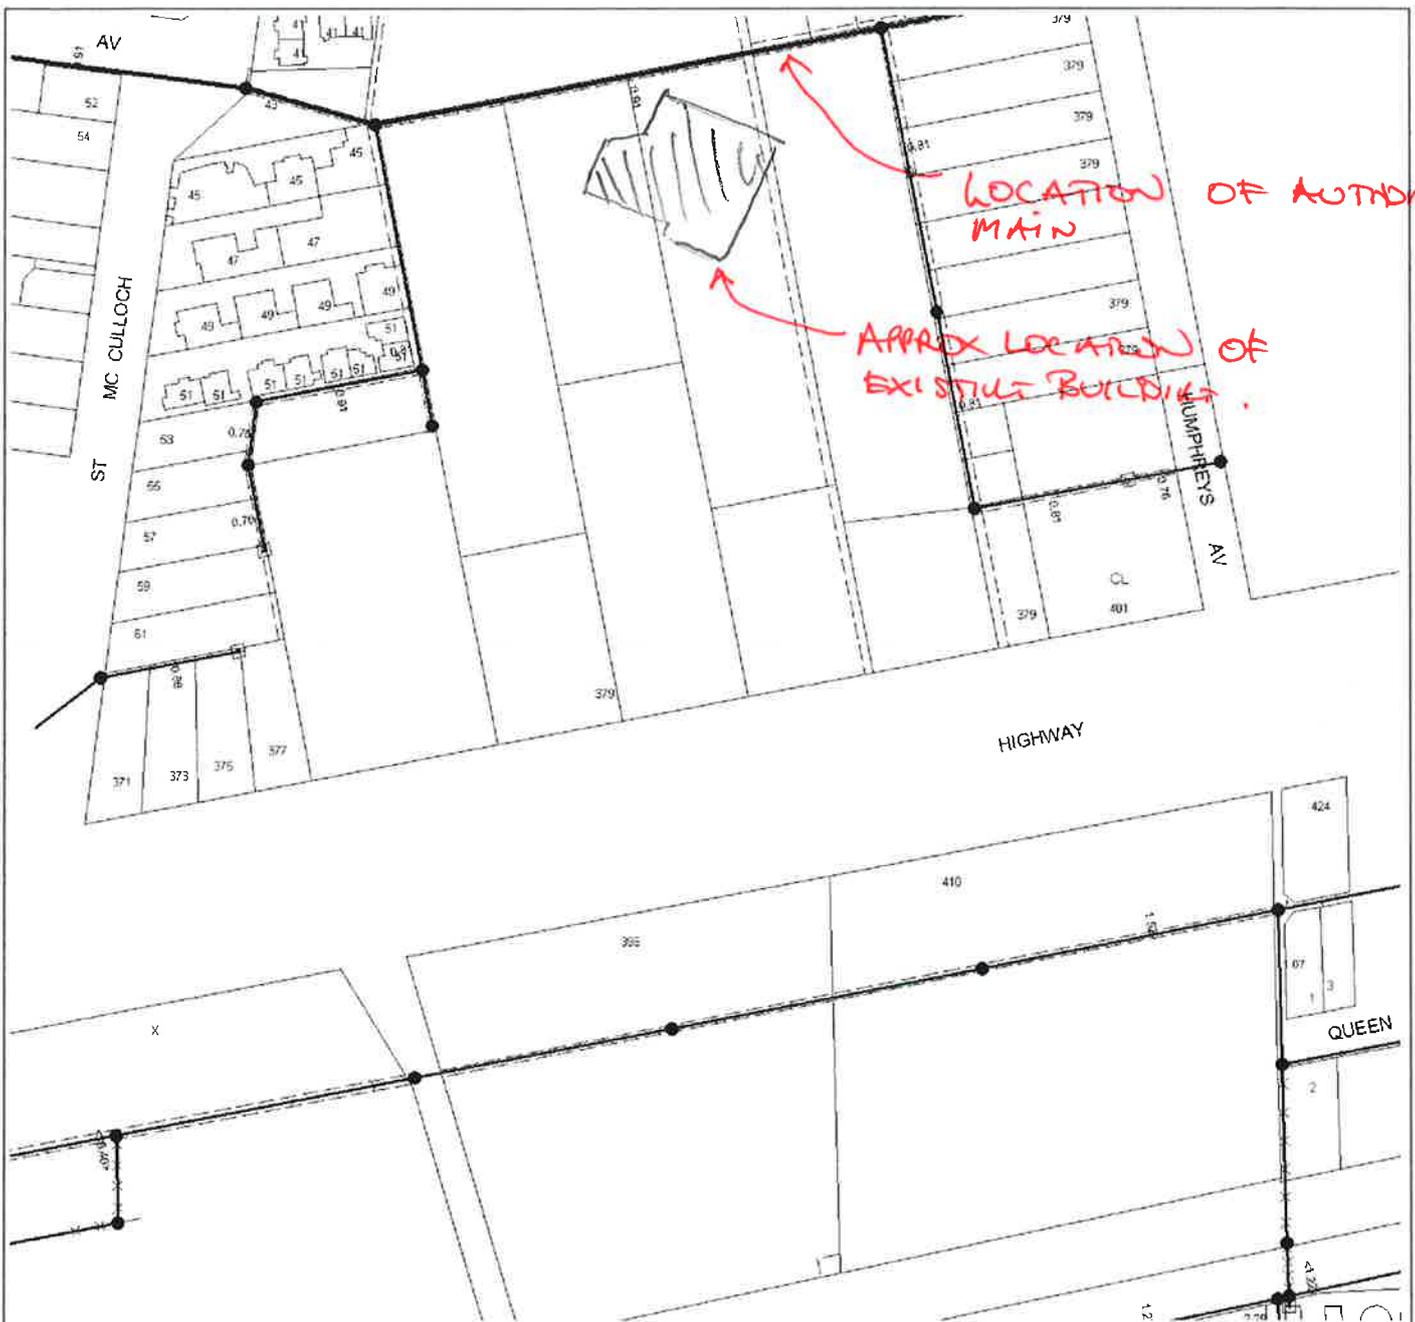
Sewer Asset Information	Address	WHITEHORSE RD NUNAWADING 3131	
	Melway Ref.	48G9	
Dial Before You Dig Sequence No.	Date	26/10/2010
