ratio:consultants

Proposed Mixed-Use Development 160 Whitehorse Road, Blackburn Response to Request for Information

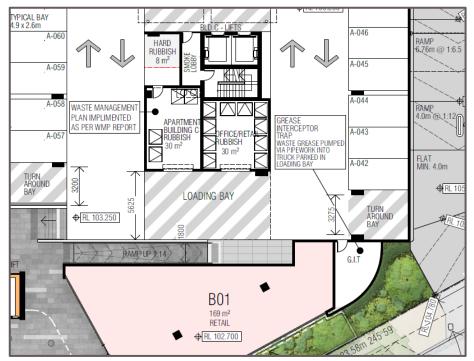
Figure 1: Grease Intercept Trap (GIT)

The Grease Intercept Trap (GIT) is located near the loading bay within Basement 1, as illustrated in Figure 1 below.

Grease collection vehicles will be able to prop within the loading bay when collecting grease and accordingly will not block access to or from any car parking spaces.

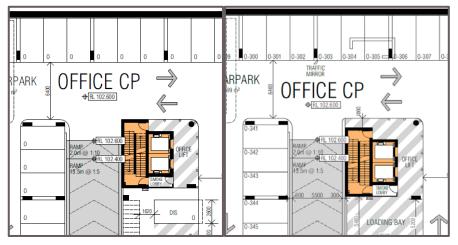
Figure 3: Changes to Internal Intersection

Furthermore, it is proposed to provide a convex mirror at this location to further improve sightlines between opposing vehicles.

The changes to this internal intersection are highlighted in Figure 3.

Accordingly, it is considered that suitable sightlines are now provided at this internal intersection to appropriately manage any conflicts between opposing vehicles.

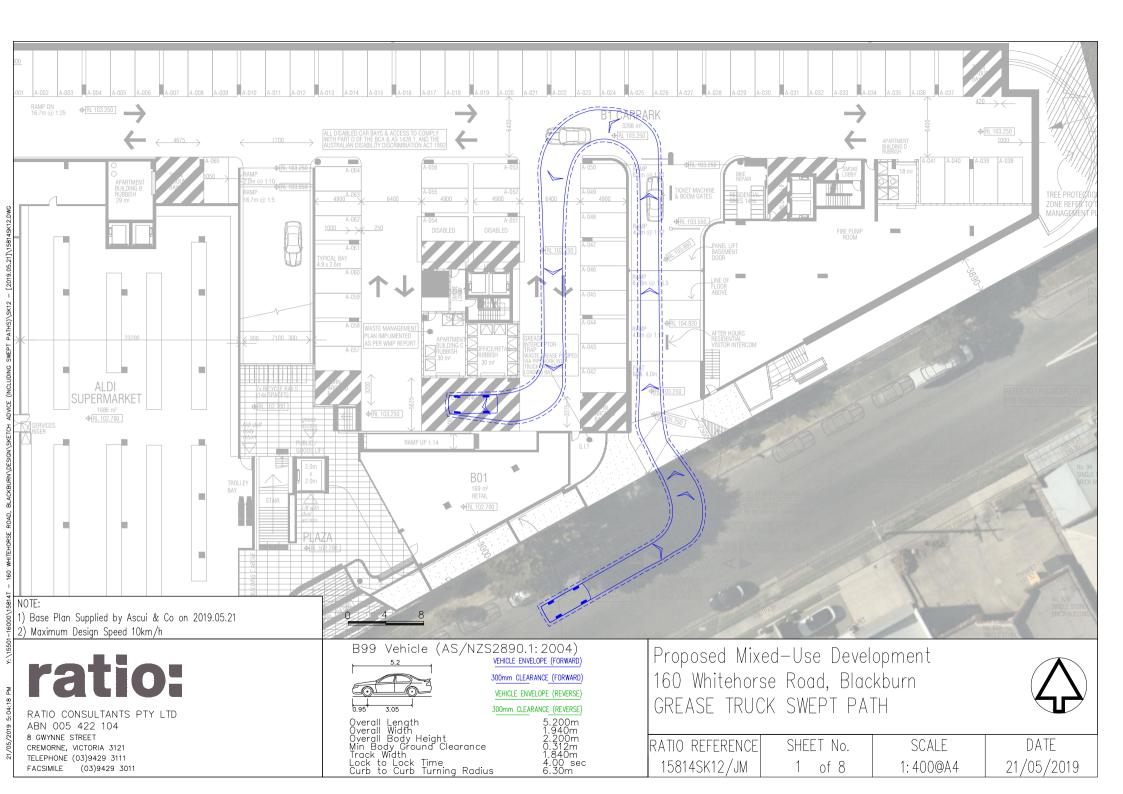
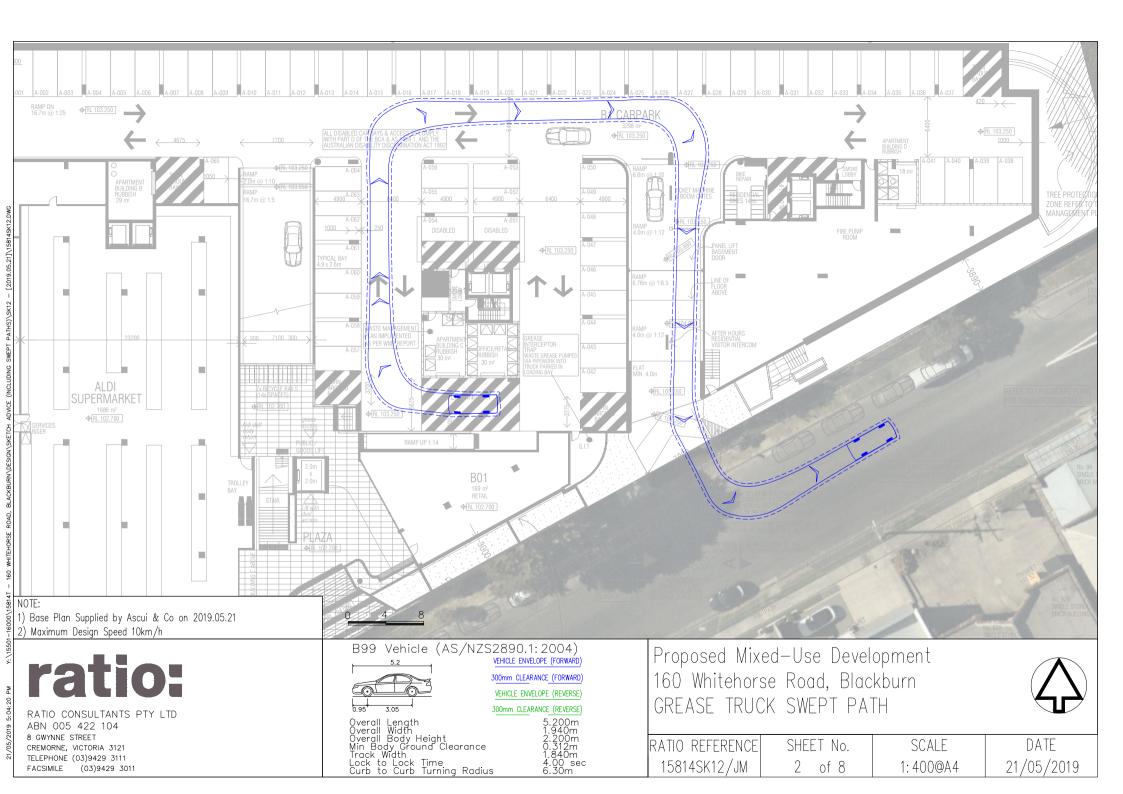
Appendix A Grease Truck Swept Path

The swept path assessment undertaken in Appendix A demonstrates the ability for the MAZDA T4600 grease removal truck to enter and exit the site in a suitable manner (modelled based on a B99 vehicle given the dimensions of this vehicle).

The smallest of the vehicles in Stows Waste Management's vehicle fleet is the MAZDA T4600 grease removal truck which has a maximum height of 2.15 metres and a length of approximately 5.0 metres.

A grease removal vehicle of this size would be able to comfortably enter and exit the site in a suitable manner, noting that the basement car park has been designed to accommodate the larger 6.4 metre Small Rigid Vehicle (SRV as defined by AS2890.2) which requires a height clearance of 3.5 metres.
